Outfall Number	Drainage Basin	Landuse	Associated With	Outfall Type	Quantity	Size (inches)	Inspection Date
OUT-001	UPPER HUDSON RIVER BASINS	Suburban Res	None	Closed Pipe	Single	36	12/30/2009
Submerged	Material	Inlet	Discharges Into	48 hrs Rainfall	Flow Present	Flow Description	Deposits\Stains
No	CMP	Catch Basin	Flowing Stream	.50 to 1.00	Yes	Substantial	No
Benthic Growth	Abnormal Vegetation	Pool Quality	Outfall Damage	Characterization (Illicit Discharge)	Street or Nearest Location		
Green	No	No	No	Unlikely	CROTON AVE

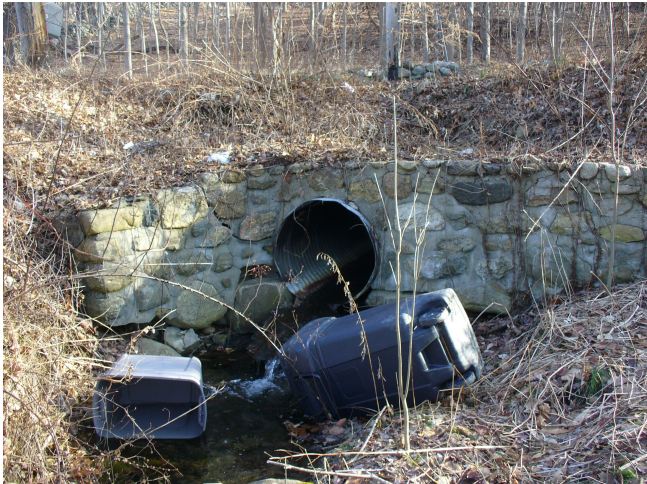
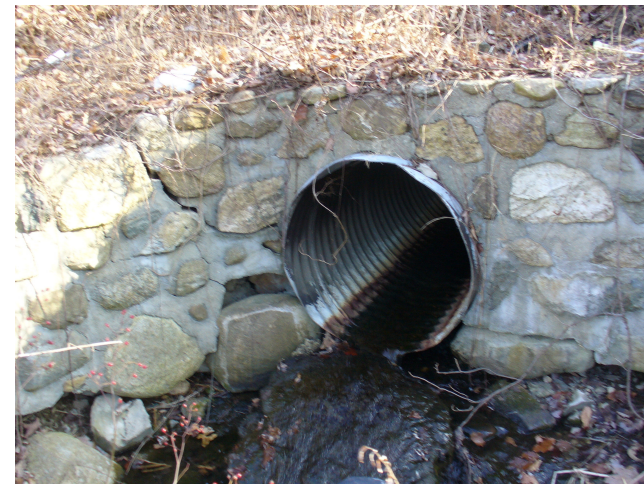
Condition: Good - Maintenance Needed: No - Notes:
