HUDSON VALLEY

Cultural Resource Consultants, Ltd.

September 14, 2021

Re: Palisades Fuel
2056-2060 E. Main Street
Town of Cortlandt, Westchester County

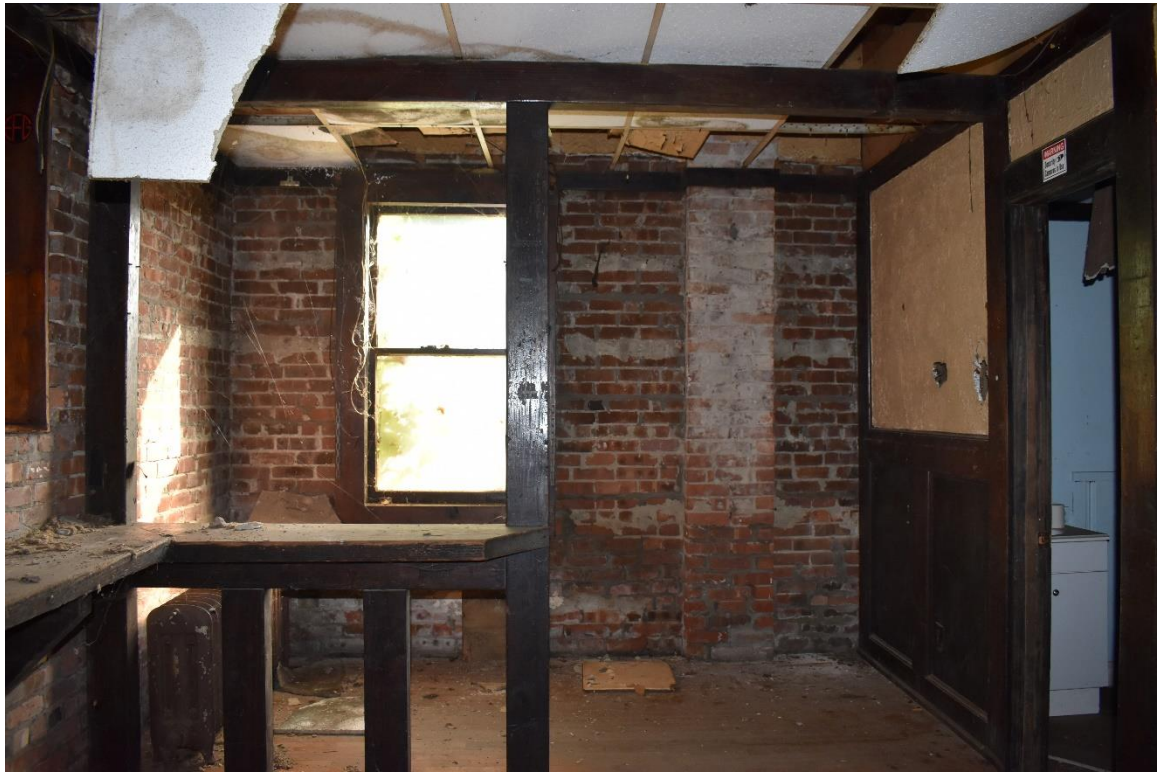
1. Interior-view to the east of the northeastern corner of the Brick Structure. Window dates to 19th century.

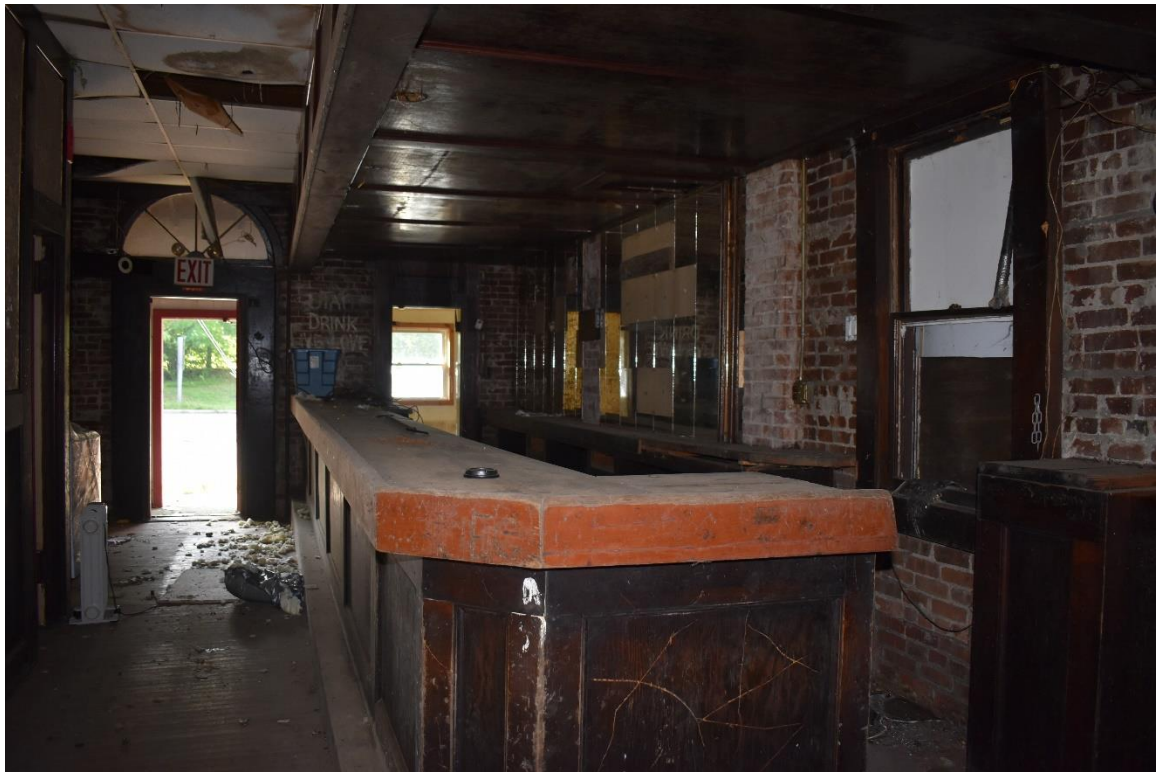
2. View to the south of the interior of the brick structure.

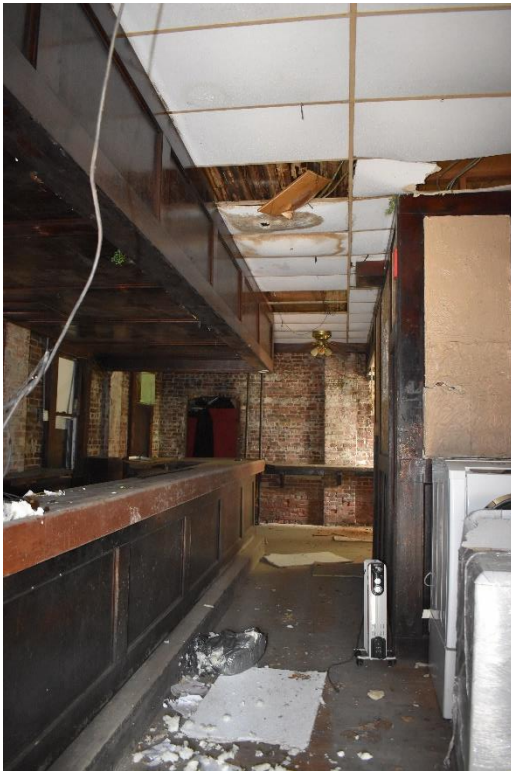
3. View to the north of the interior of the brick structure. Interior walls and drop ceiling are modern additions.

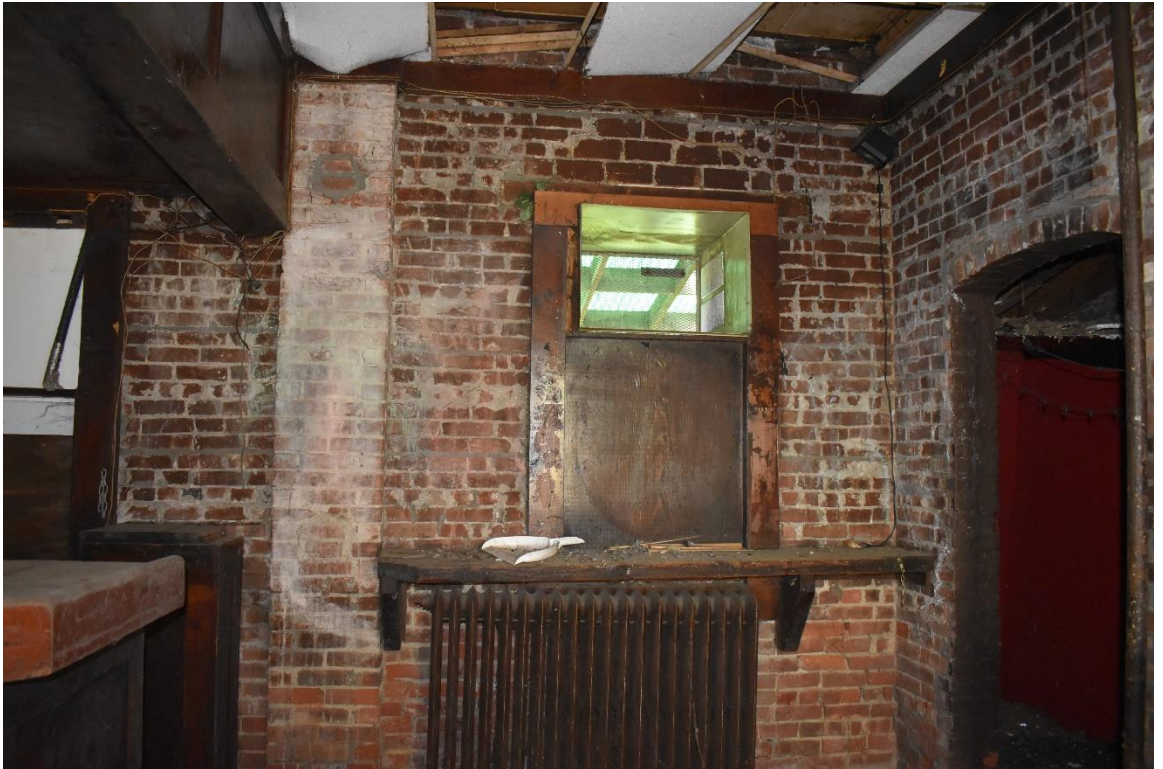
4. View to the west of the northwestern portion. Steam radiators are later additions.

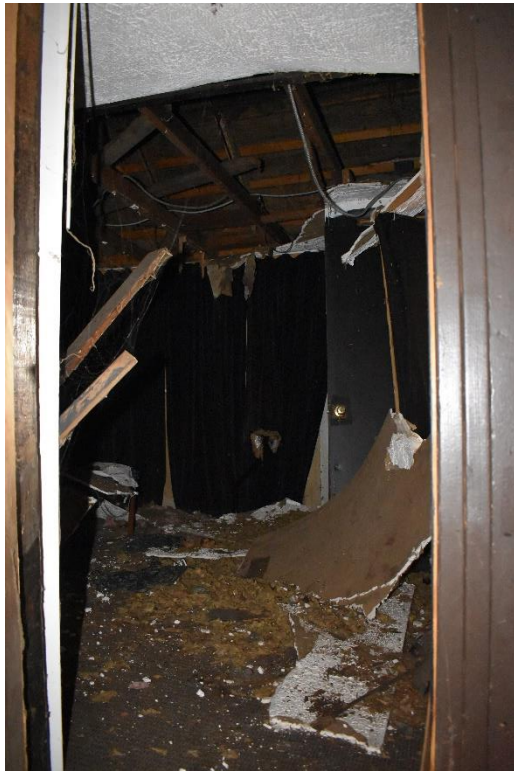
Interior walls are constructed with sheet rock. In the northern addition, the interior finish materials have significantly deteriorated, and the wall boards have collapsed away from the roof and brick wall. The southern addition consists of the former restaurant kitchen, and entry way and is a late 20th century addition. The second floor has been fully altered in the mid to late 20th century to function as an apartment. This renovation included the addition of two dormers on the western side of the building. The southernmost dormer is no longer sealed against the elements, and significant water damage has caused deterioration of the interior. There is notable bowing in the exterior of the roof on the southern side of this dormer. The northernmost dormer is the location

5. View to the northeast of the northern addition. The interior of this space is deteriorating.

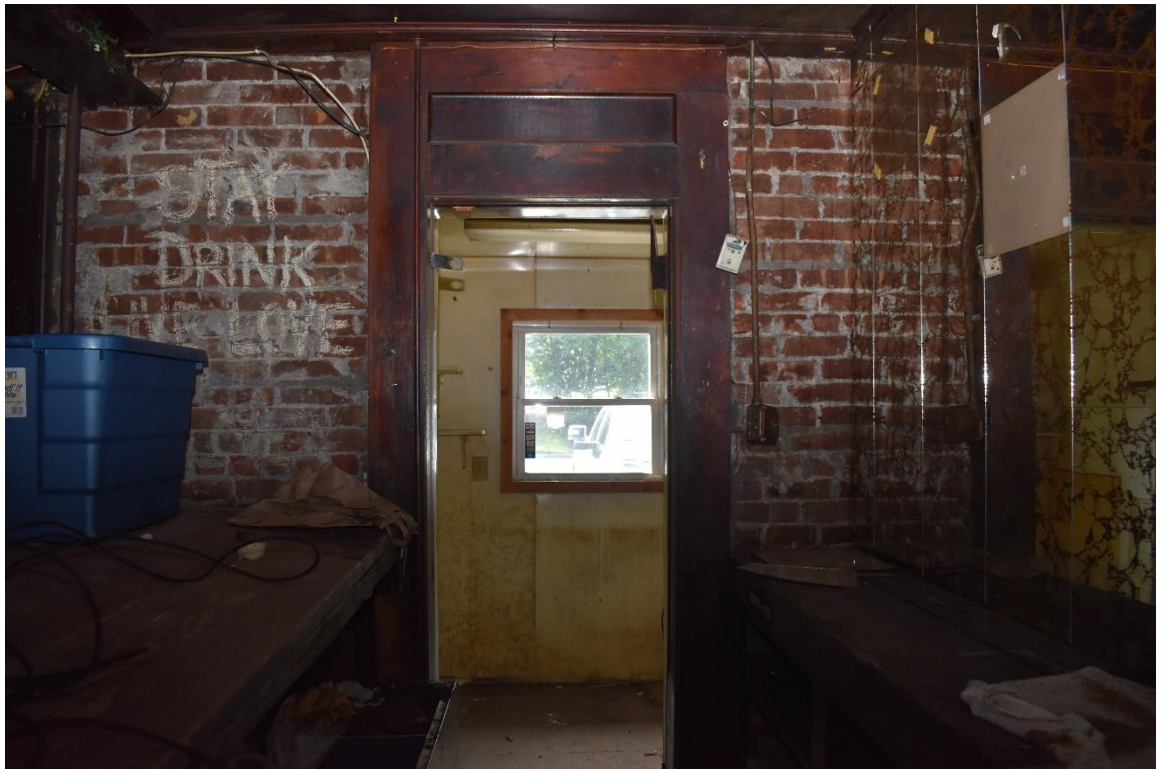
6. View to the south toward the kitchen addition on the southern side of the building.

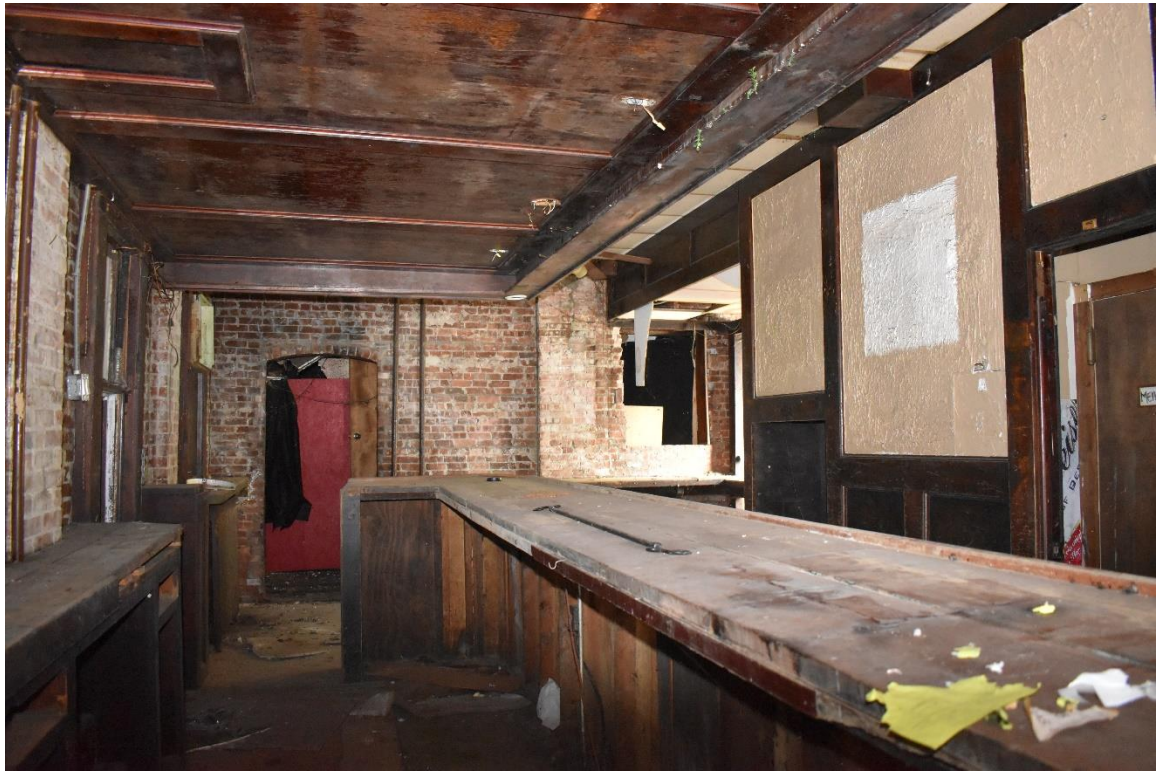
7. View to the north from the southwestern corner of the brick structure.

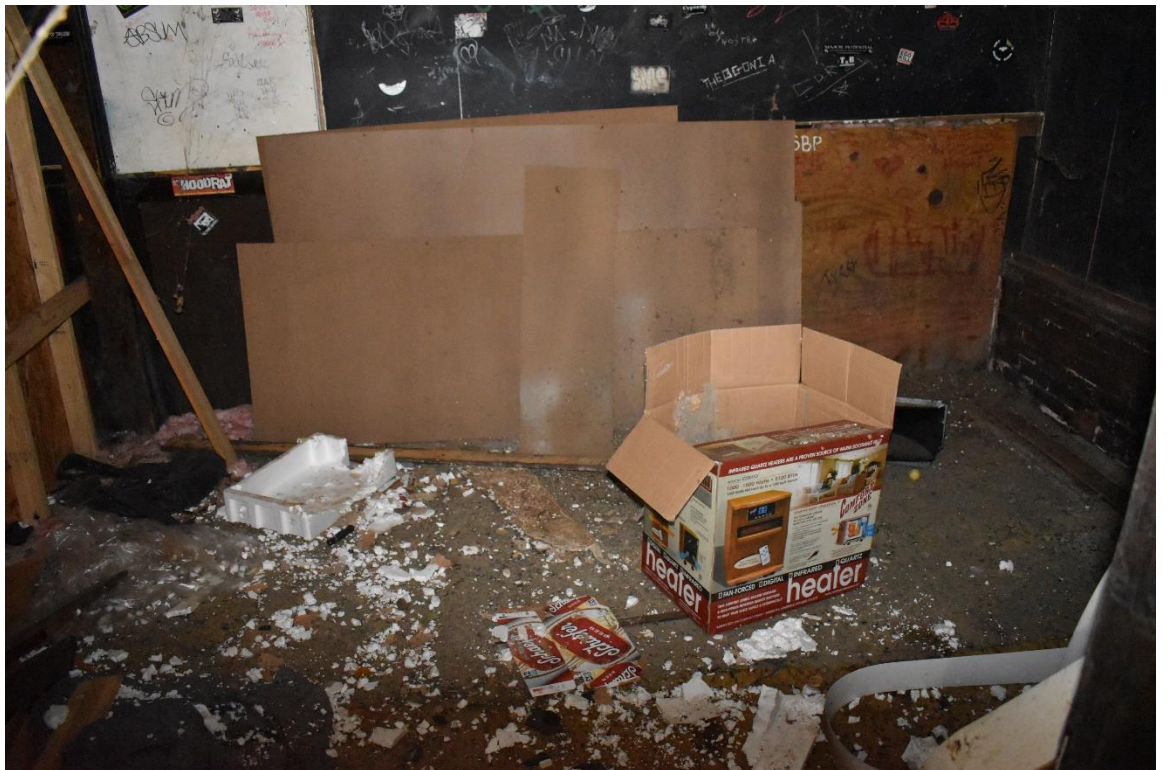
8. View to the west of the northern addition.

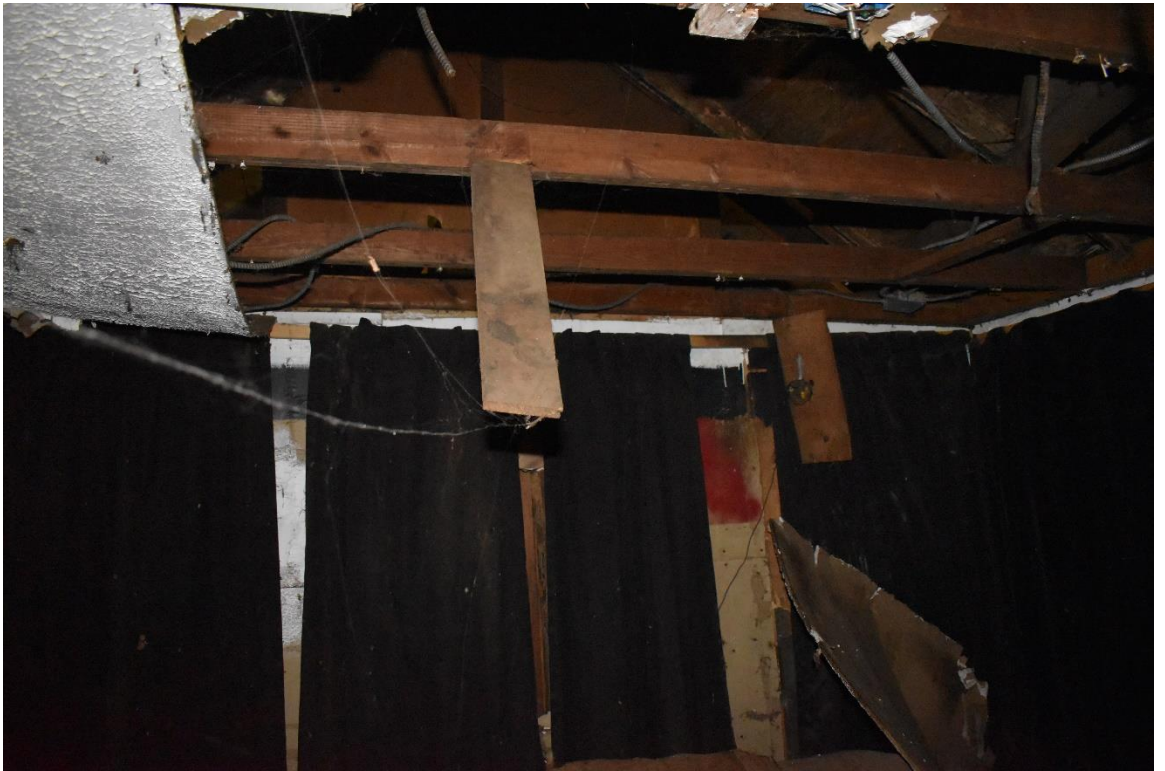
9. View to the north of the northern addition. Lumber indicates a mid-late 20th century construction date.

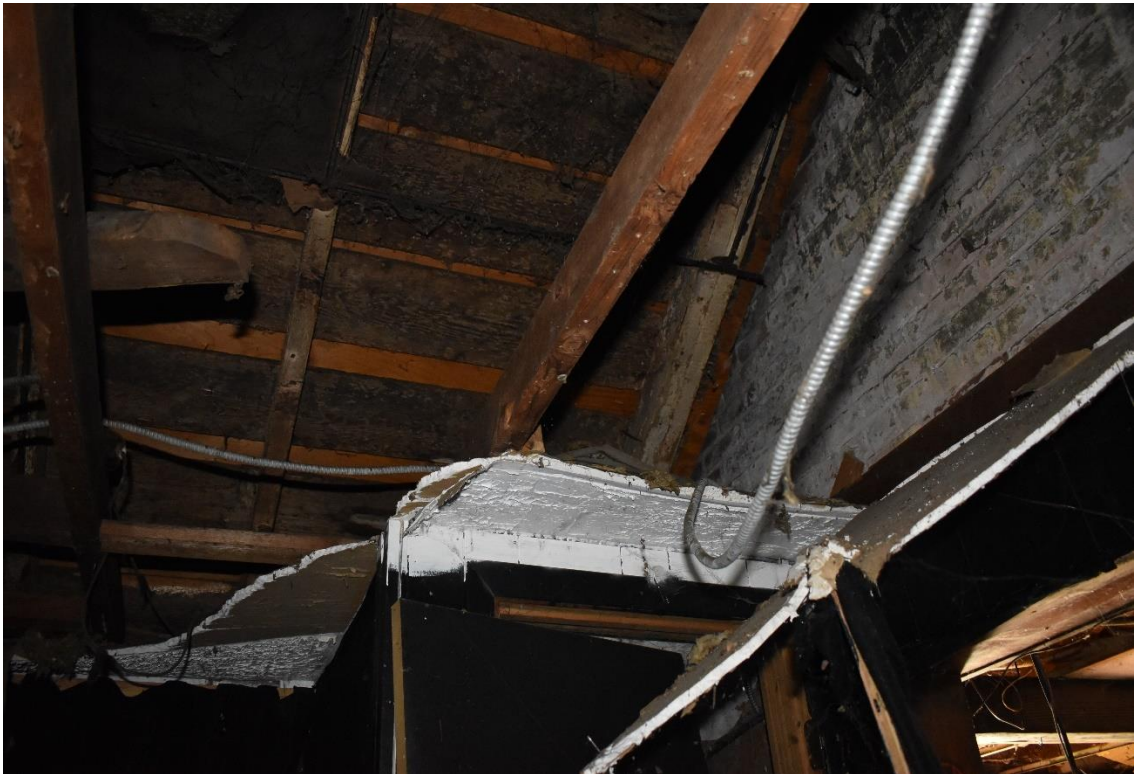
10. The interior of the northern addition has completely deteriorated. View to the southeast.

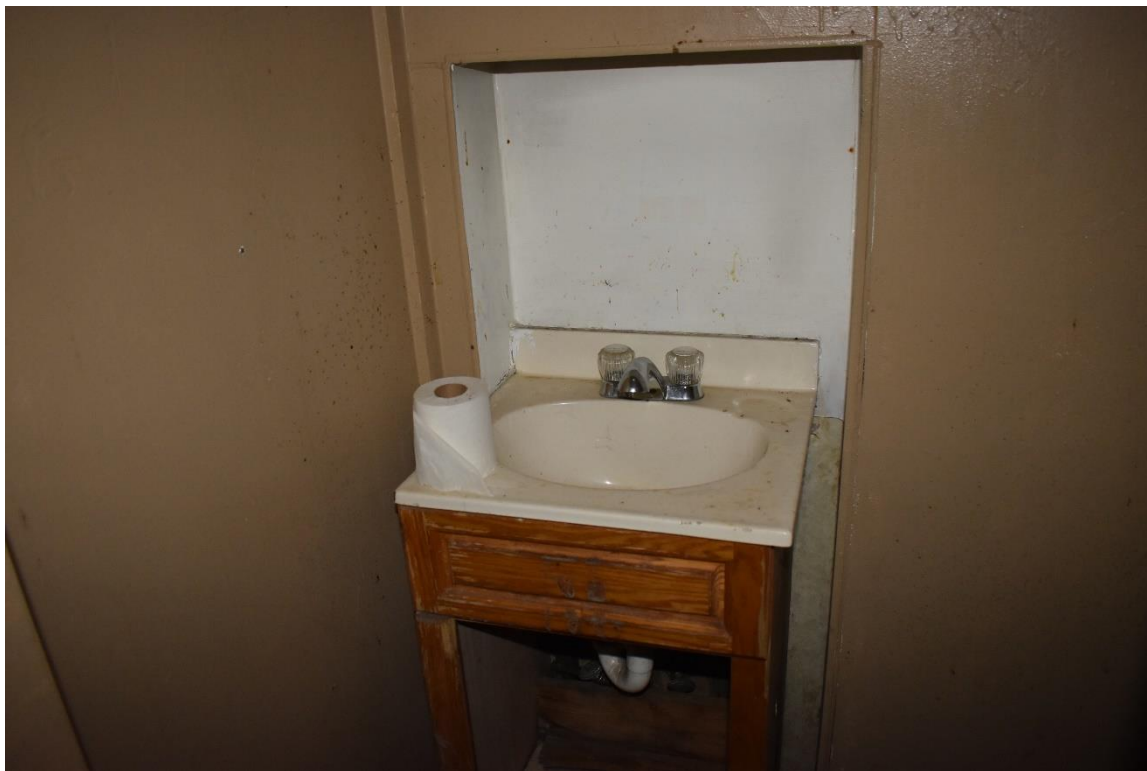
11. Bathroom in the interior of the brick structure. View to the west.

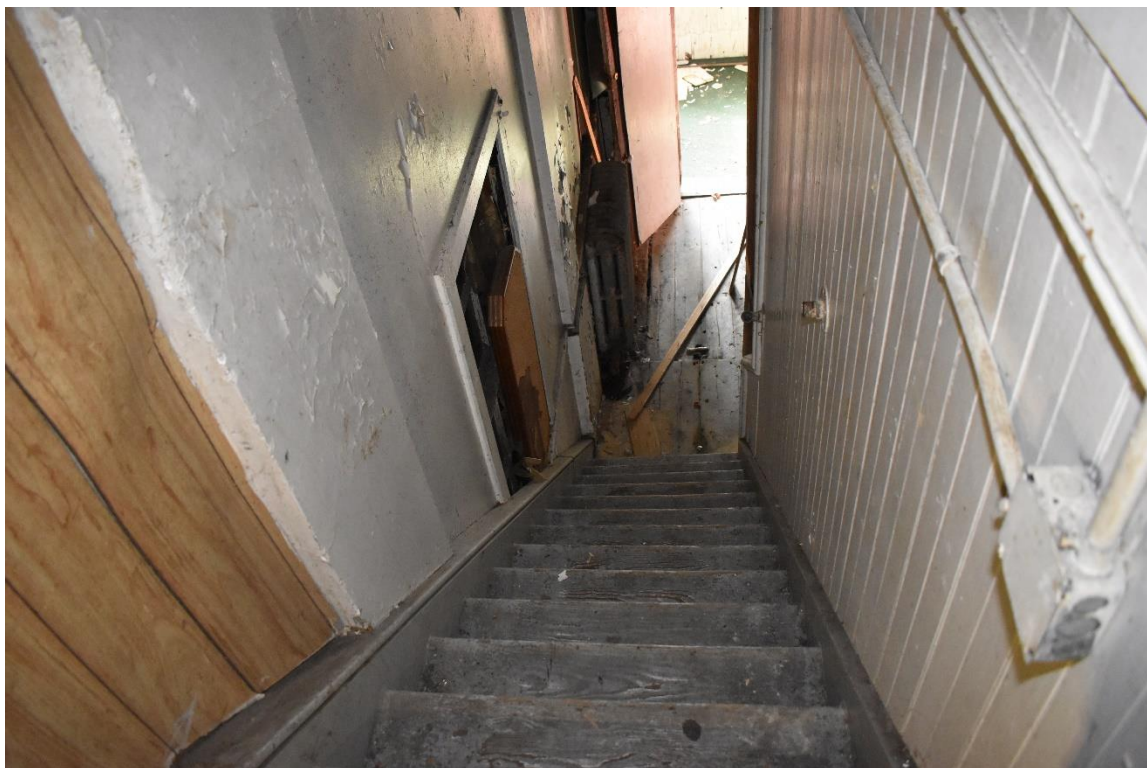
12. Stairs leading to the second floor. View to the south.

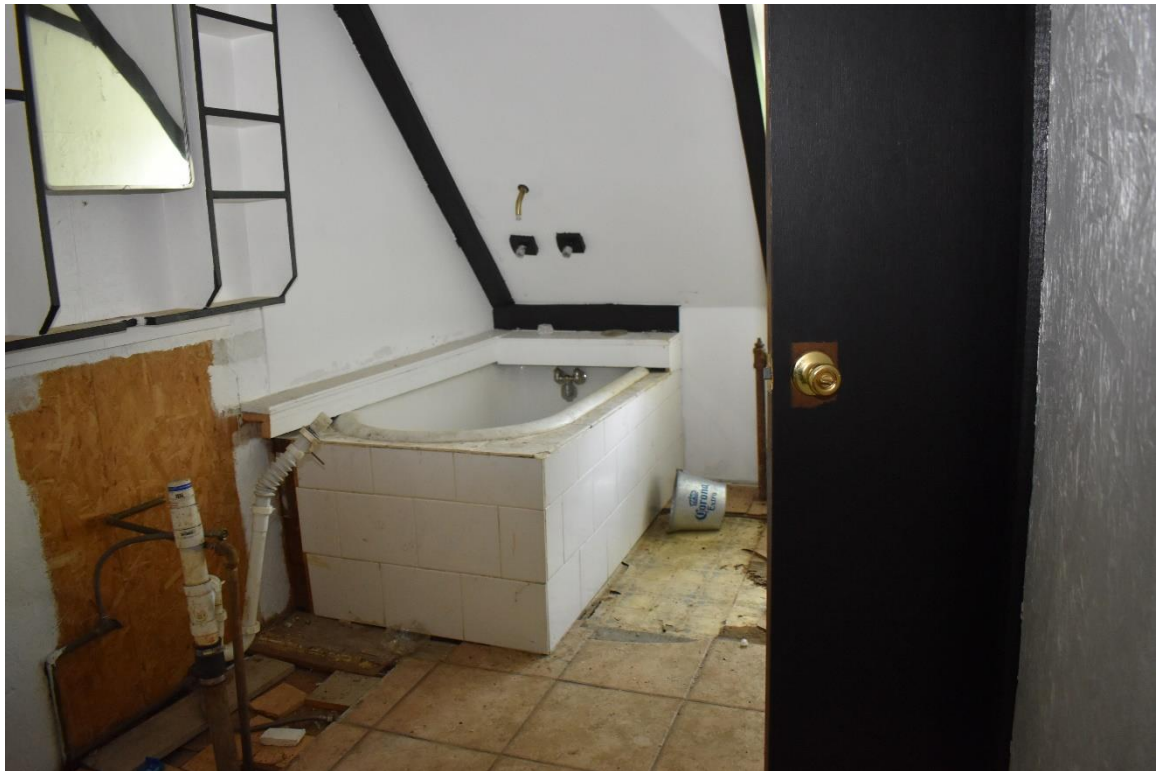
13. Bathroom on second floor. View to the southwest.

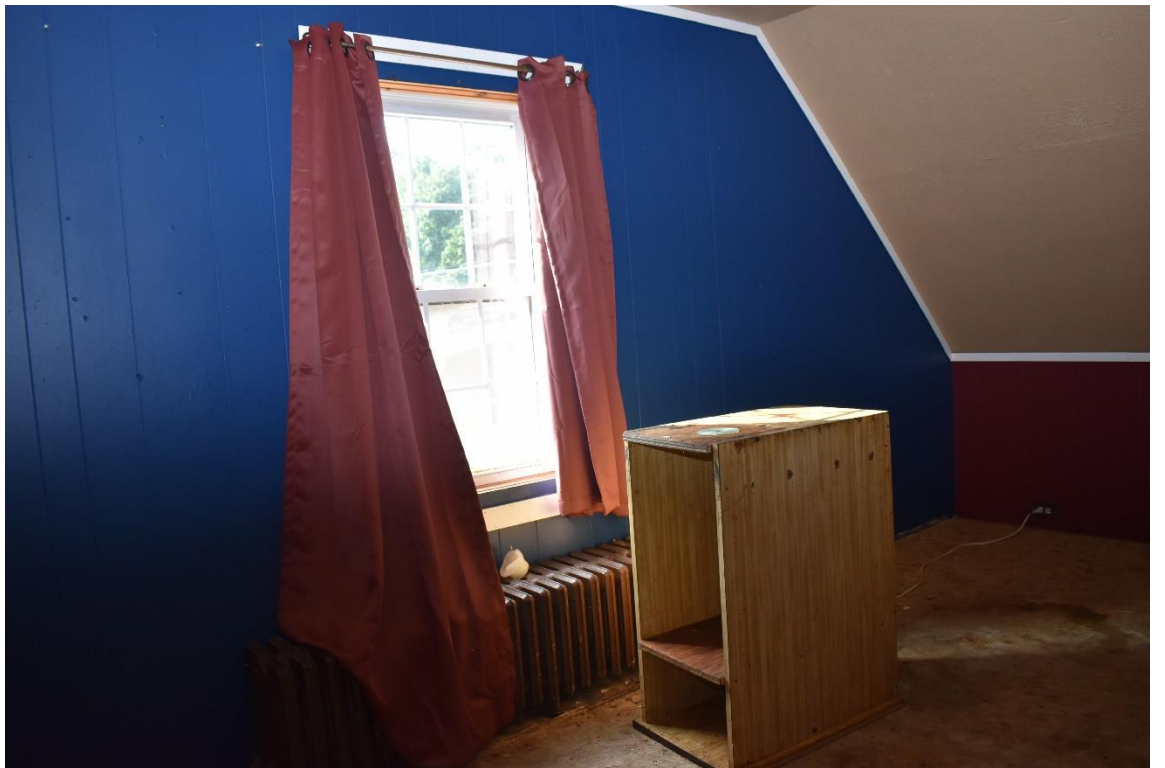
14. View to the southwest of southern window. Window is a modern vinyl replacement.

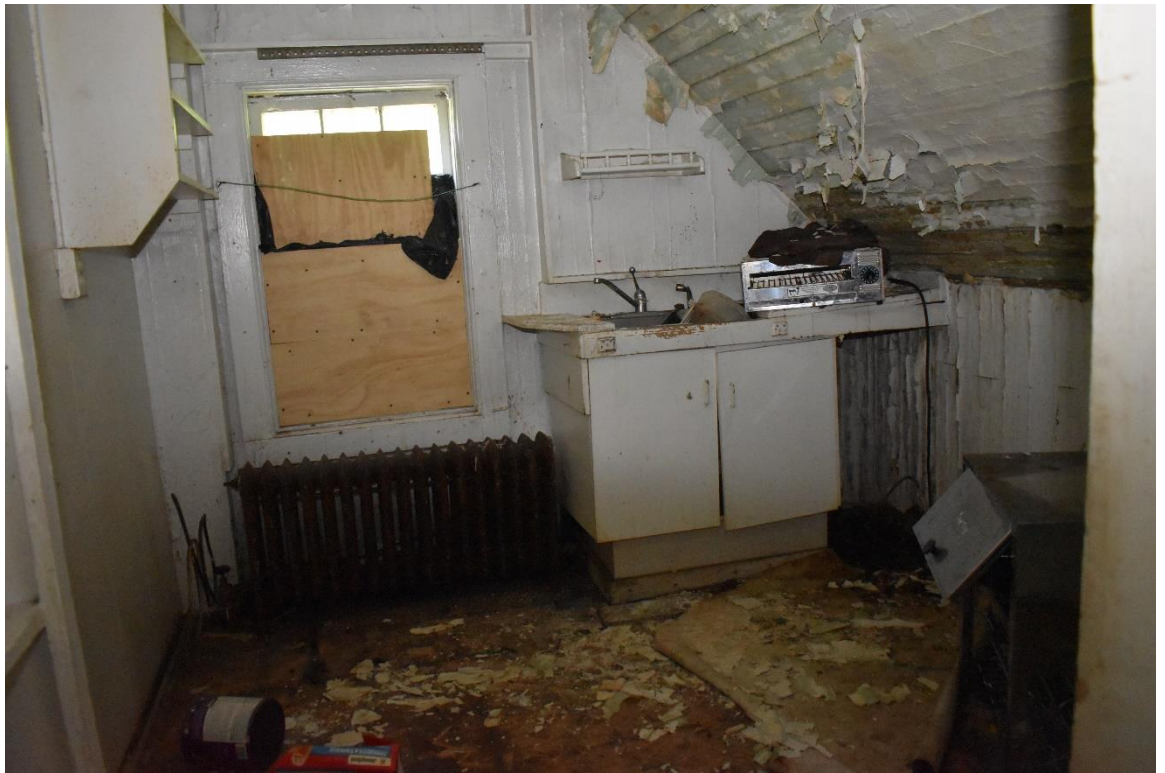
of the apartment's kitchen. This area has also experienced significant water damage, as the northern wall is bowing inward, and does not appear to be structurally sound.

15. View to the west of the northern dormer and addition on second floor. Shiplap to the right in photos is collapsing inward.

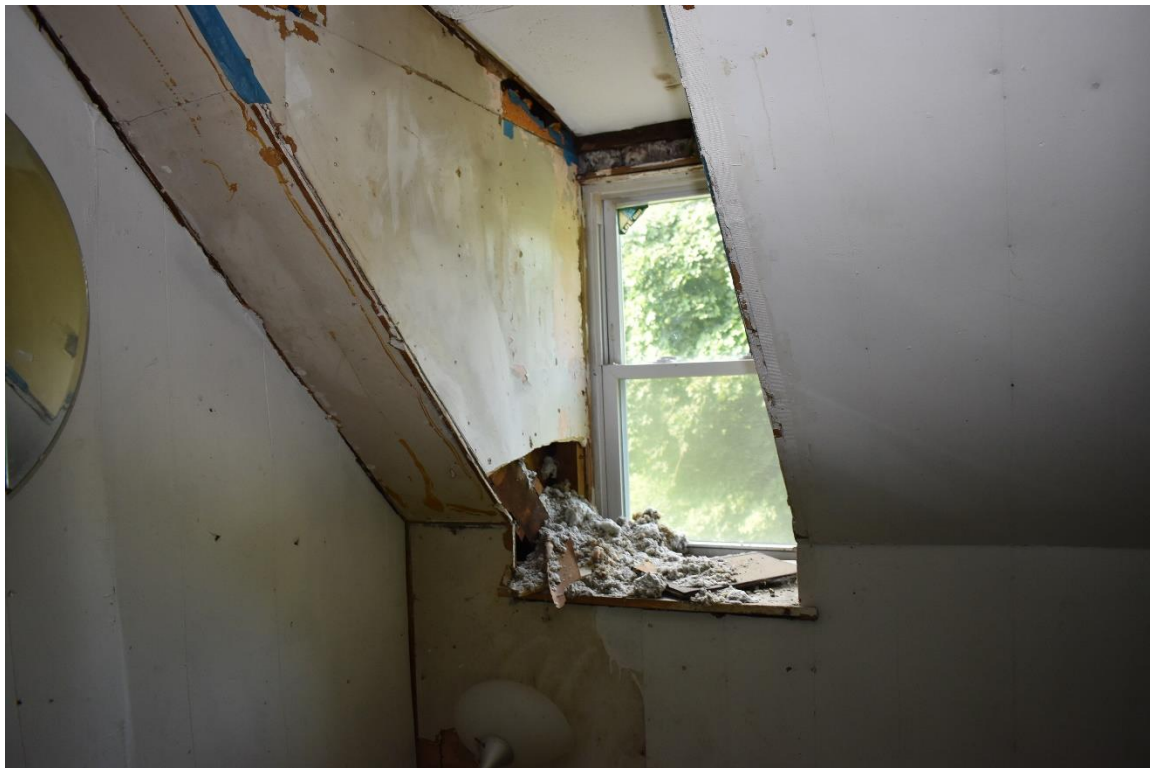
16. View to the southwest of the southern dormer. Note the significant water damage.

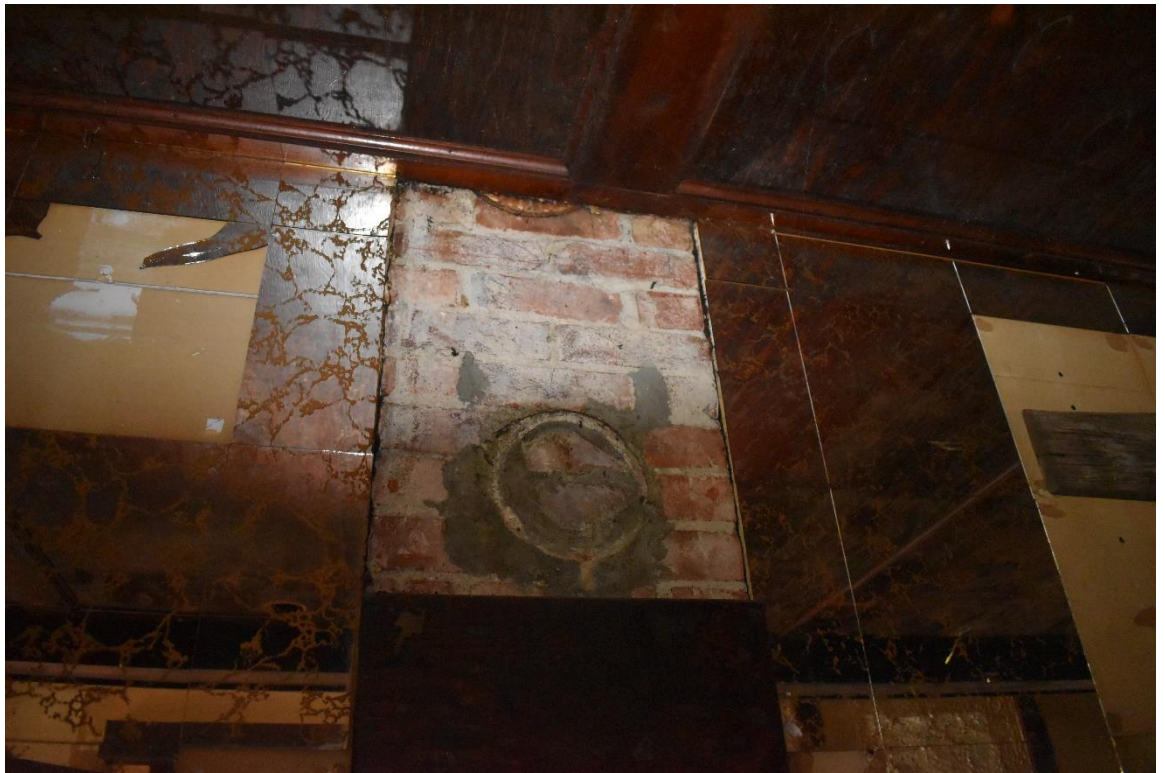
17. The original stove and piping have been removed.

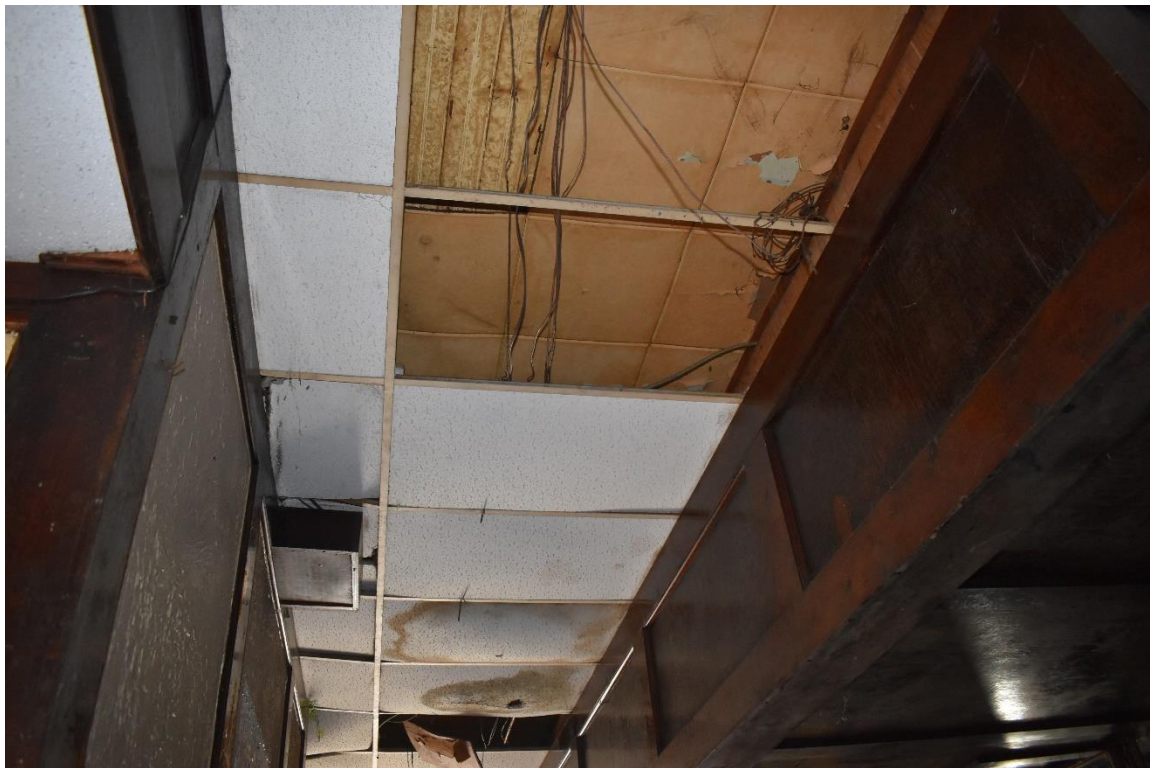
18. Drop Ceilings cover earlier iterations of ceiling materials and house HVAC components.

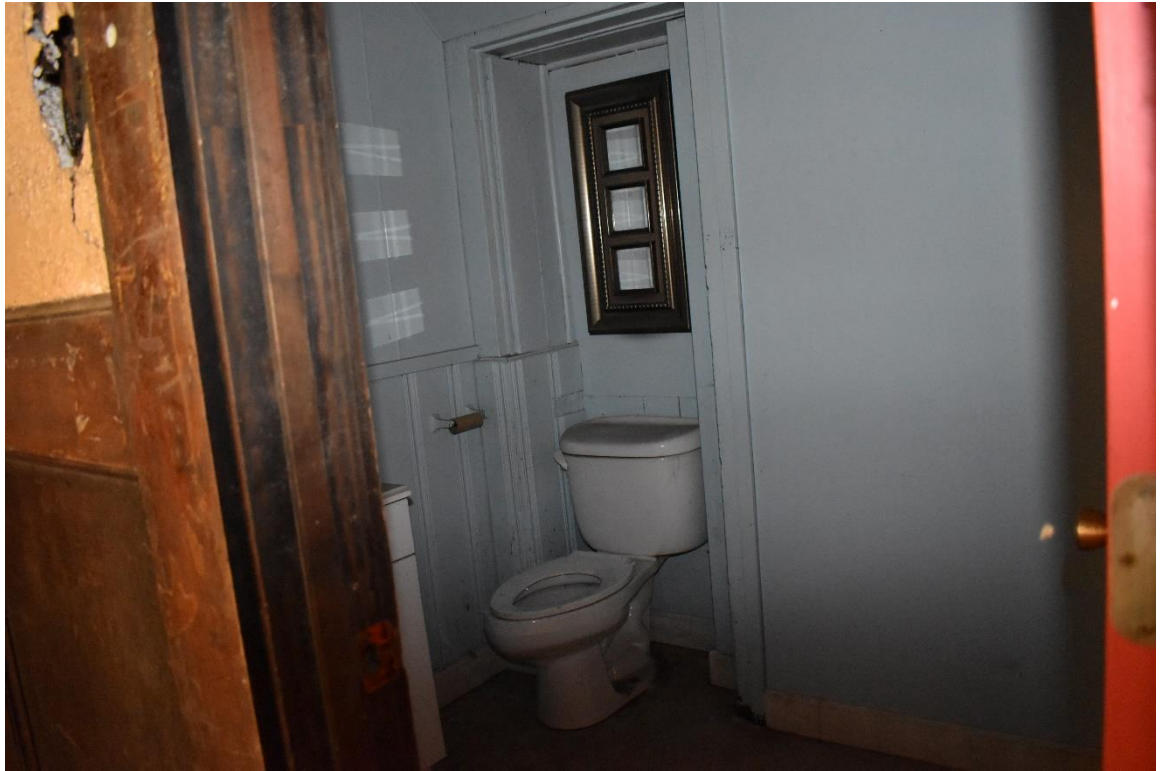
19. Second bathroom in interior of brick structure.

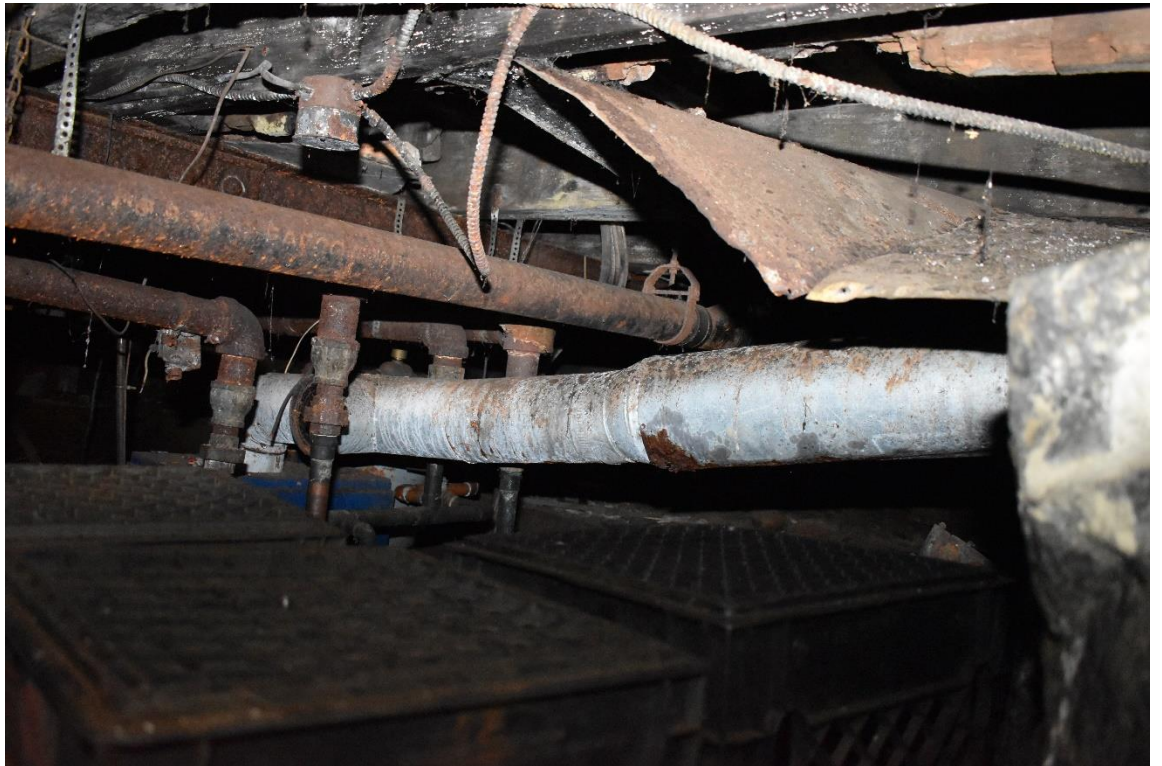
20. Pipes and mechanicals are located in the basement of the structure.

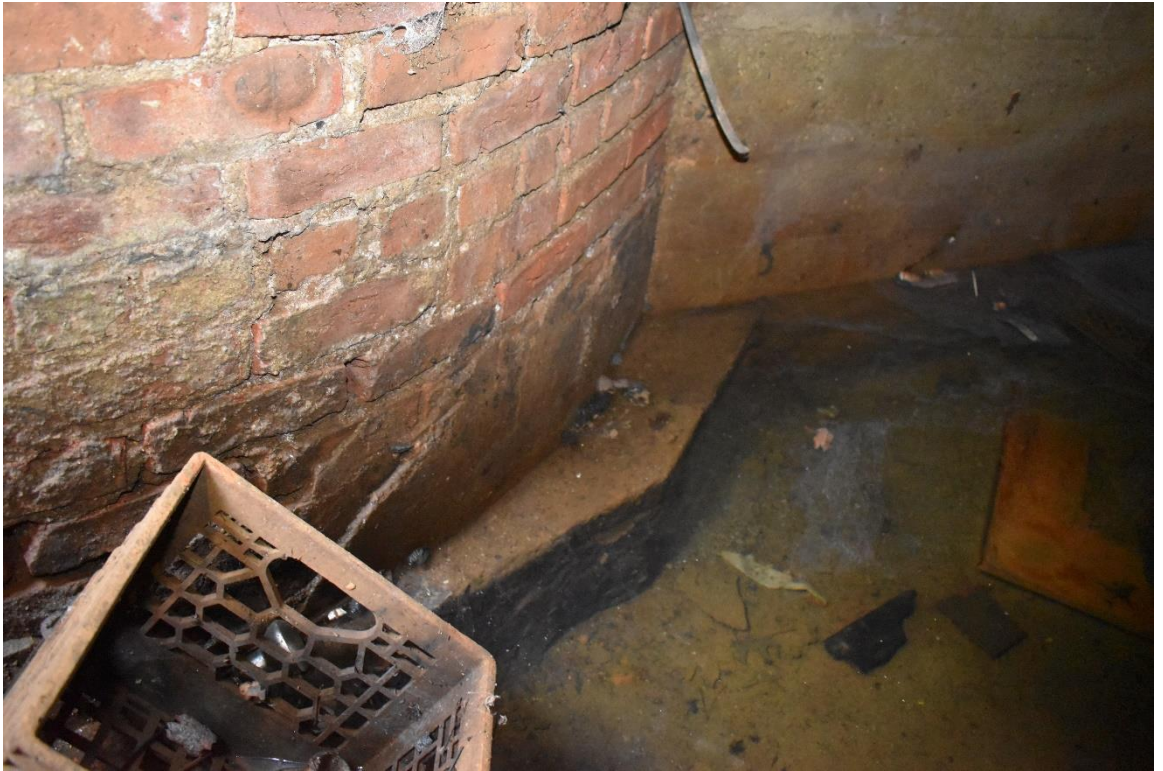
21. Foundation is constructed of brick and parged with cement.

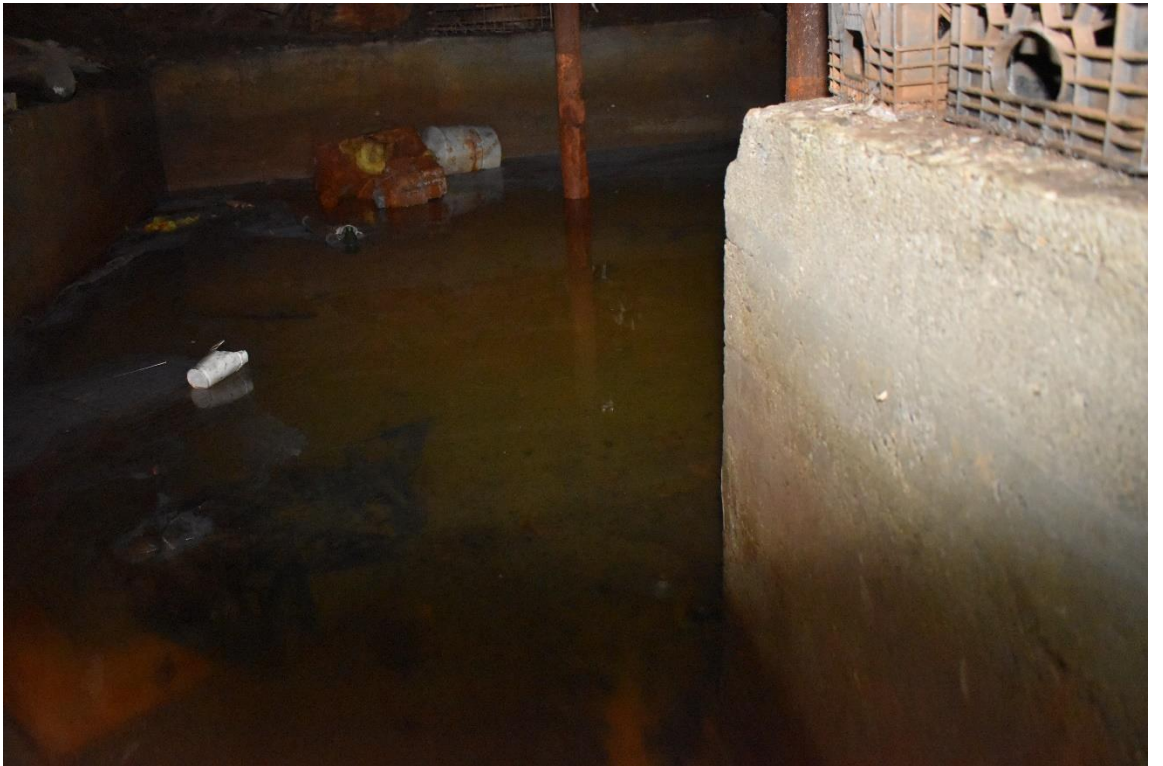
The foundation of the Brick Structure has been constructed of mortared brick which has been parged over with a layer of cement. Currently there is more than two feet of water within the basement of the structure. The basement features cast iron supports, on which the floor joists rest. These supports are covered with rust. The numerous pipes and mechanical components in the basement also exhibit deterioration and corrosion. The floorboards were black with rot and contained substantial amounts of mold and fungus.

22. Substantial amounts of water were noted in the basement.

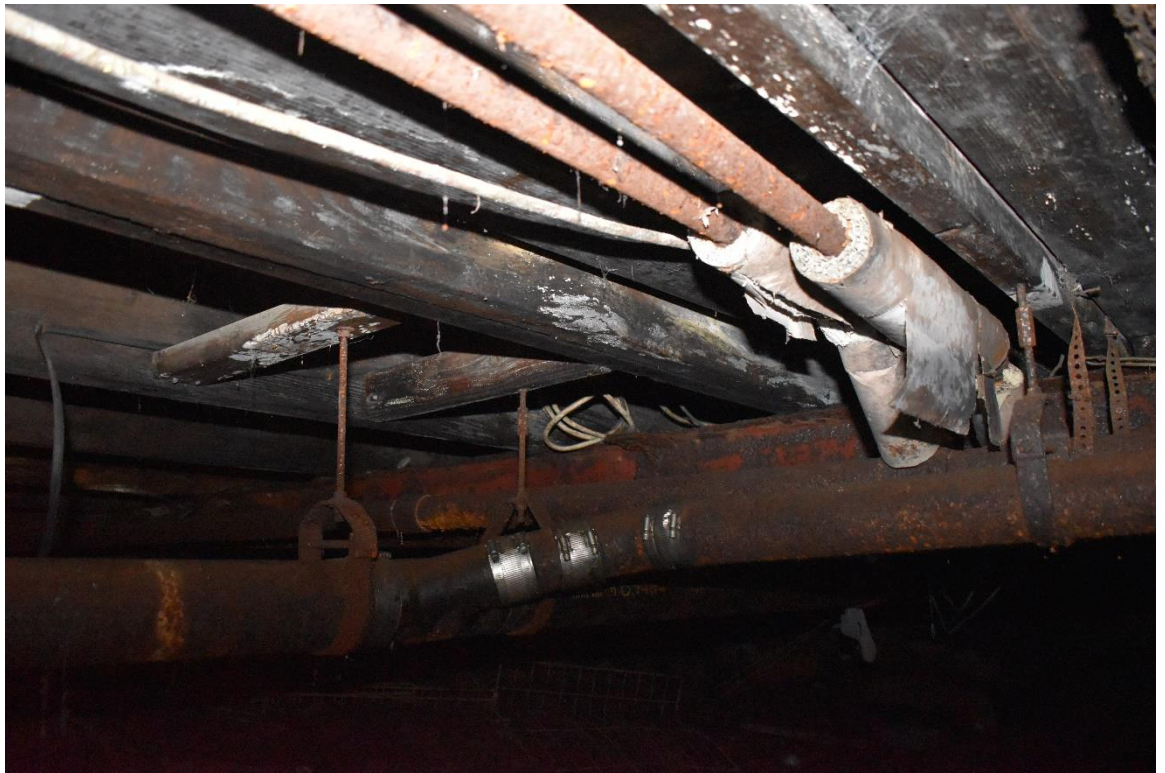
23. The water infiltration has caused the pipes and floor joists to deteriorate.

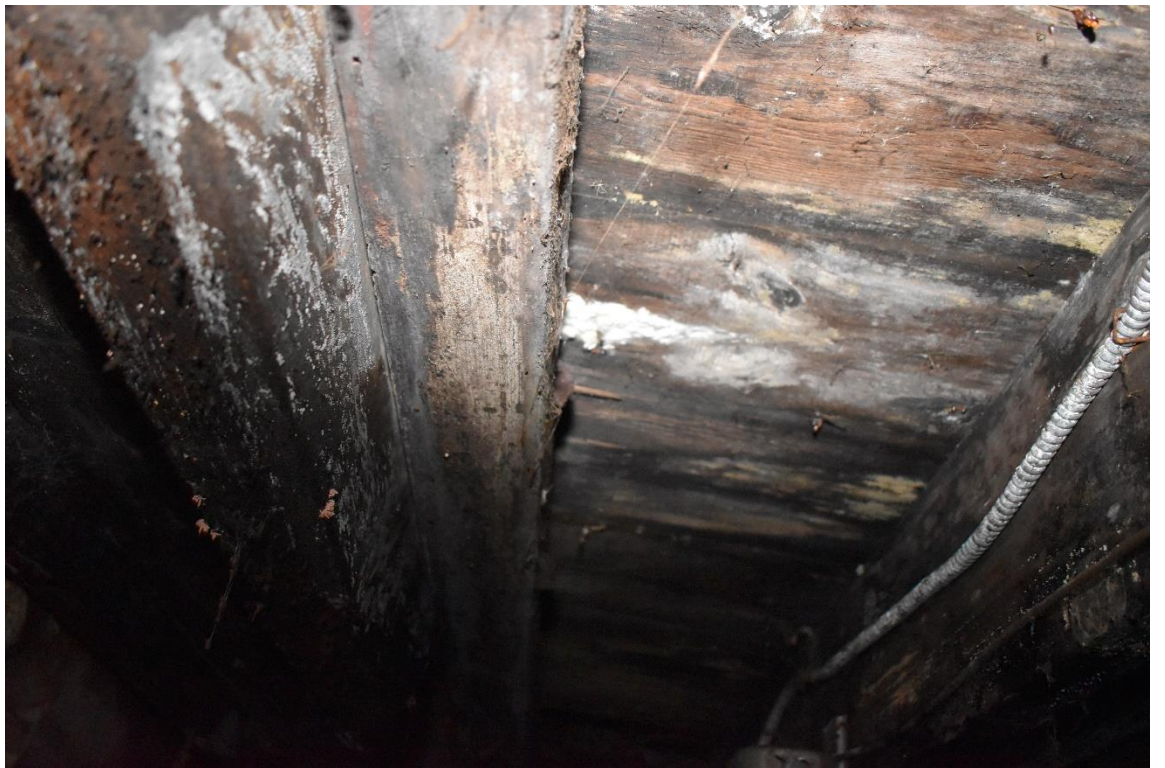
24. A significant amount of rot, mold and fungus were noted in the floor joists.

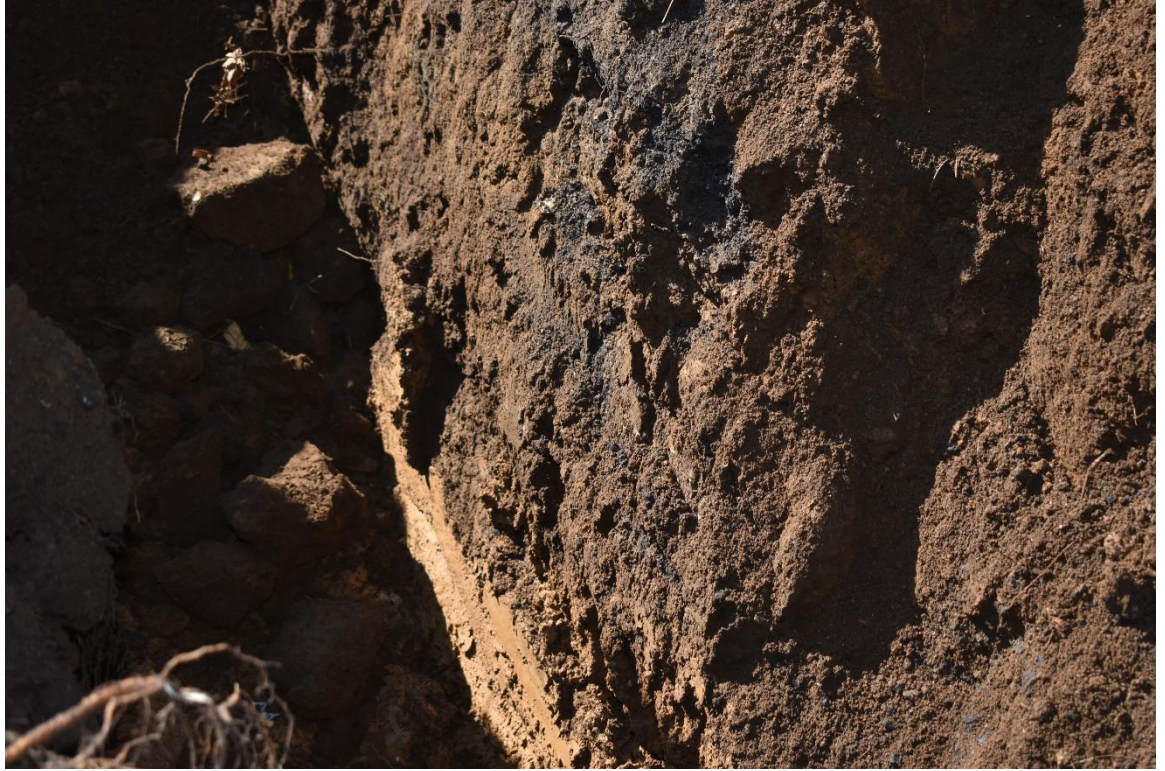
1. The test trench identified fill consisting of soil, asphalt, gravel and asphalt dust.

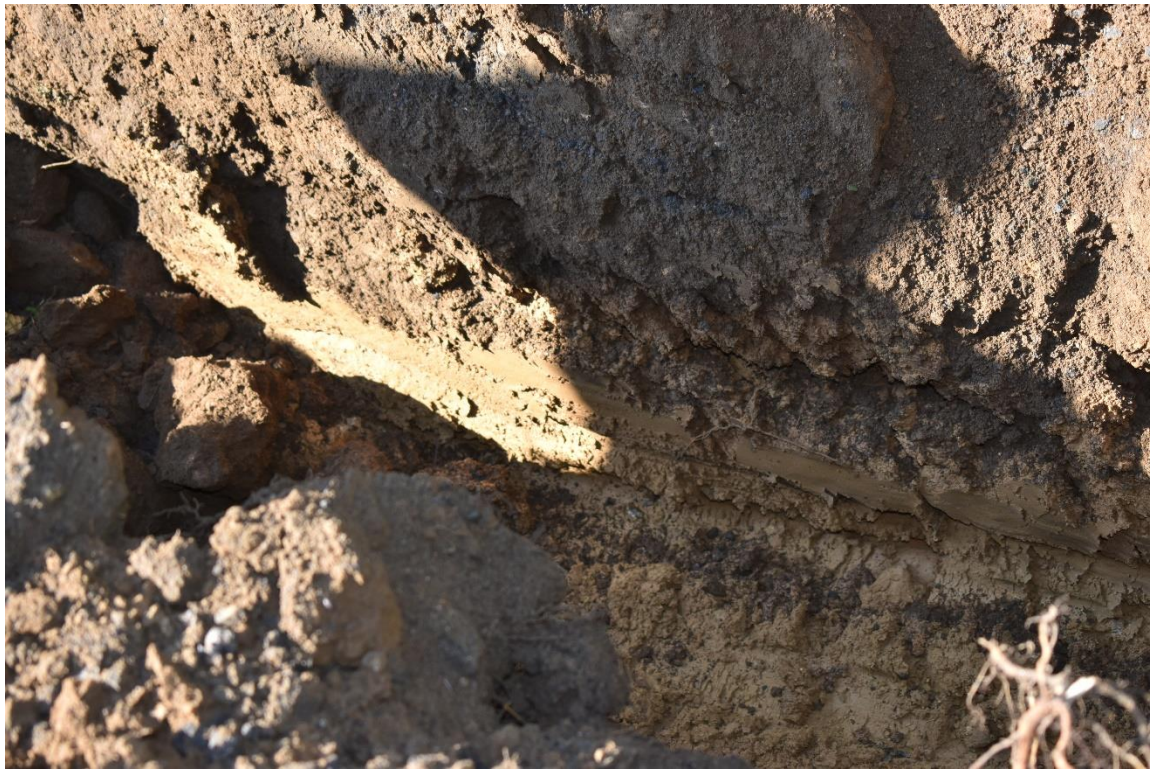
2. The fill material is located on top of glacial subsoil.
