HUDSON VALLEY

Cultural Resource Consultants, Ltd.

September 14, 2021

Re: Palisades Fuel
2056-2060 E. Main Street
Town of Cortlandt, Westchester County

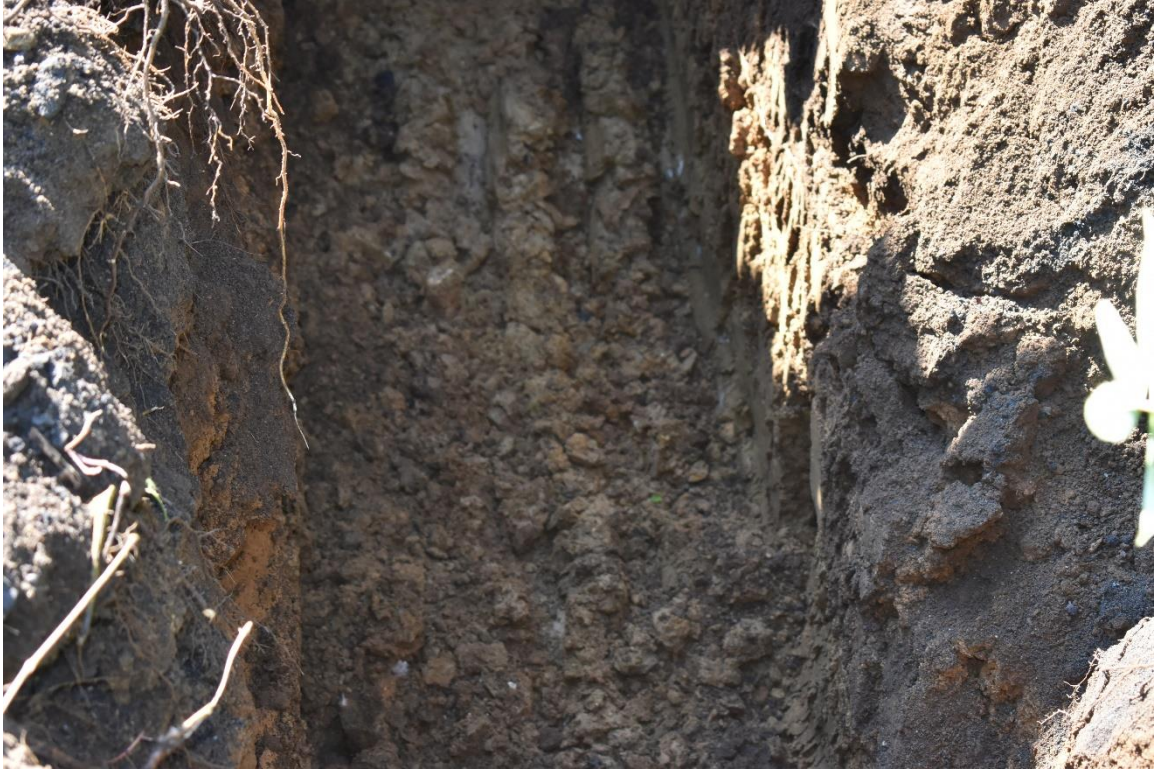
3. Bedrock was encountered at a depth of 6' below grade.

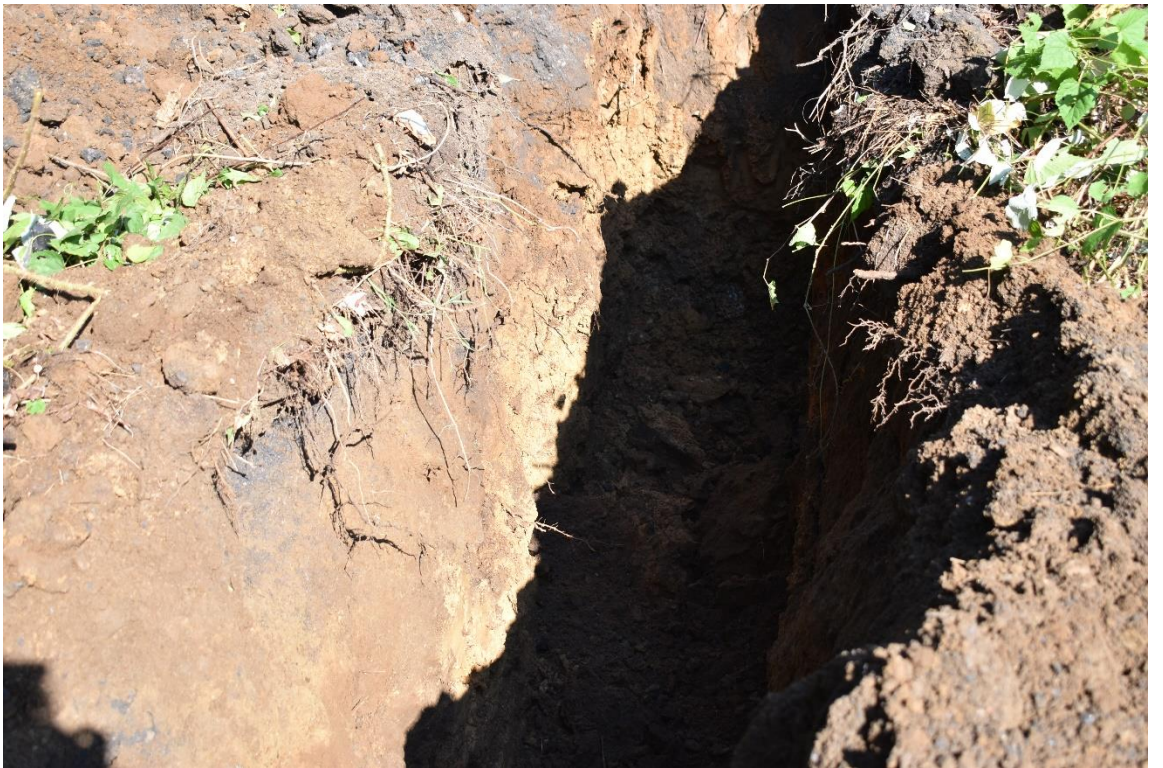
A test trench was completed on the western side of the building on September 13, 2021. The careful monitoring of mechanically excavated trenches is a common practice to determine if a burial ground is present.¹¹ The location was chosen as it represented a level area that would have been the most likely location of a community burial ground. The soil profile identified consisted of 2.5'-3' of fill soils (top soil mixed with asphalt, asphalt dust and gravel) overlying glacially sterile soil (C horizon). The existing soil profile indicates that at one time the original top soil was removed, and the area was leveled and graded with soils brought in from another area. Bedrock was reached at 6' below grade in this location. Photographs of this test trench are included as Exhibit B. Test pits completed elsewhere within the Project Parcel by the Applicant's Environmental Consultant indicate that the depth to bedrock is roughly 2'-4' below grade. This shallow depth of bedrock, mixed with the numerous boulders makes this an unlikely location for a burial ground.

4. The test trench was 15' in length, on the western side of the brick structure.
