Tectonic	Copies	
Town of Cortlandt Department of Technical Services 1 Heady Street, Cortlandt Manor, NY 10567		
RE: TECTONIC W.O. 10740.DIC VERIZON SITE ID: DICKERSO 260 CROTON AVENUE CORTLANDT MANOR, NY 10 TOWER CERTIFICATION LET SECTION/BLOCK/LOT: 34.1	KERSONMT	October 15, 2021
To Whom It May Concern, Tectonic Engineering Consultants presenting this certification for the the above-mentioned property res Cortlandt outlined below.	existing wireless telecommunic	cations facility (second at
Special Use Permit: Case No. 2015 - Name of Petitioner: New York SMS Date Original Permit Granted: Nove	A Limited Partnership D/b/a Ve	rizon Wireless
The Facility comprises of a 140' ta fenced compound at the base of # 20160775 issued by the Town of 0	of the tower. The Facility was	s installed under permit

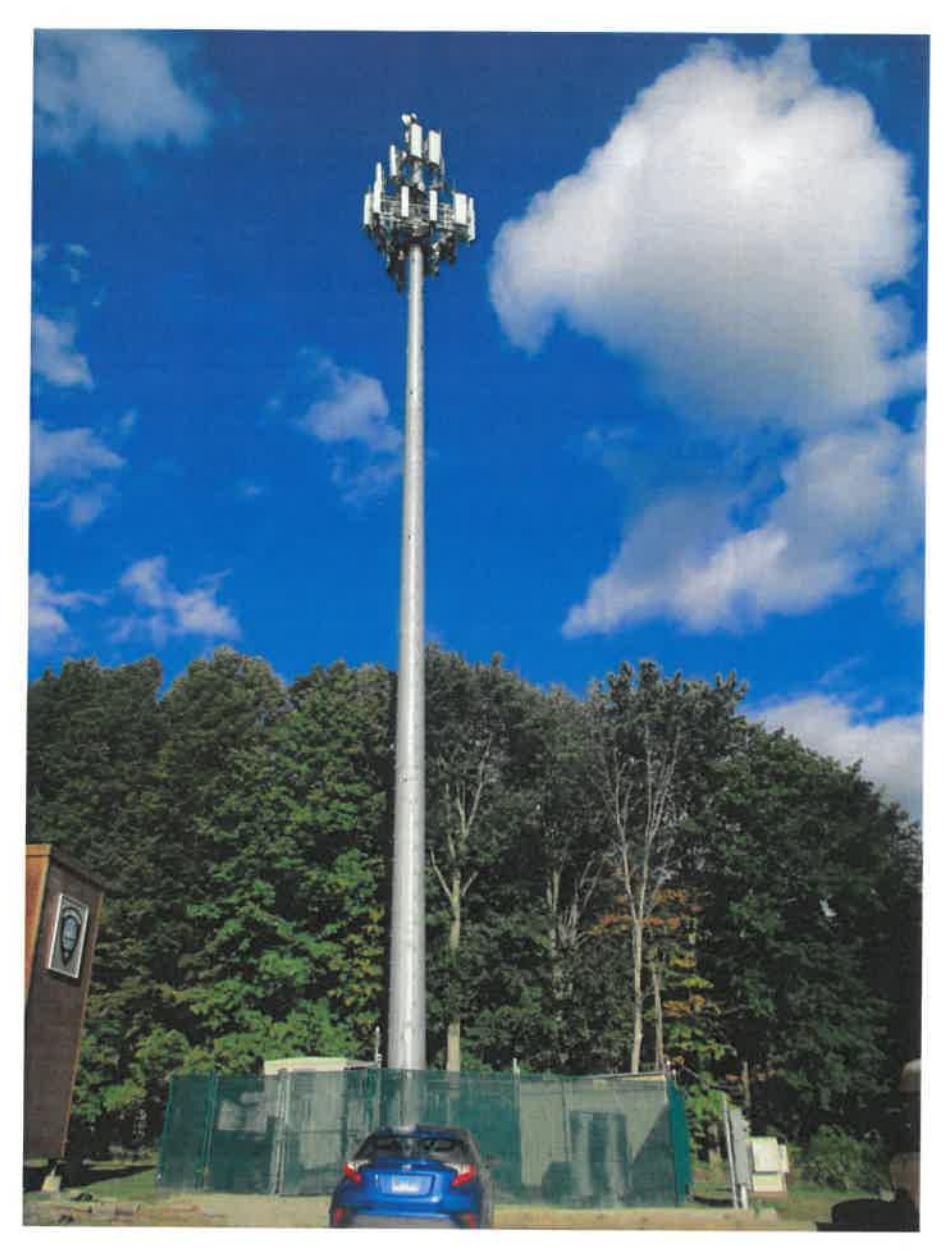
Photo 1: Overall view of the pole

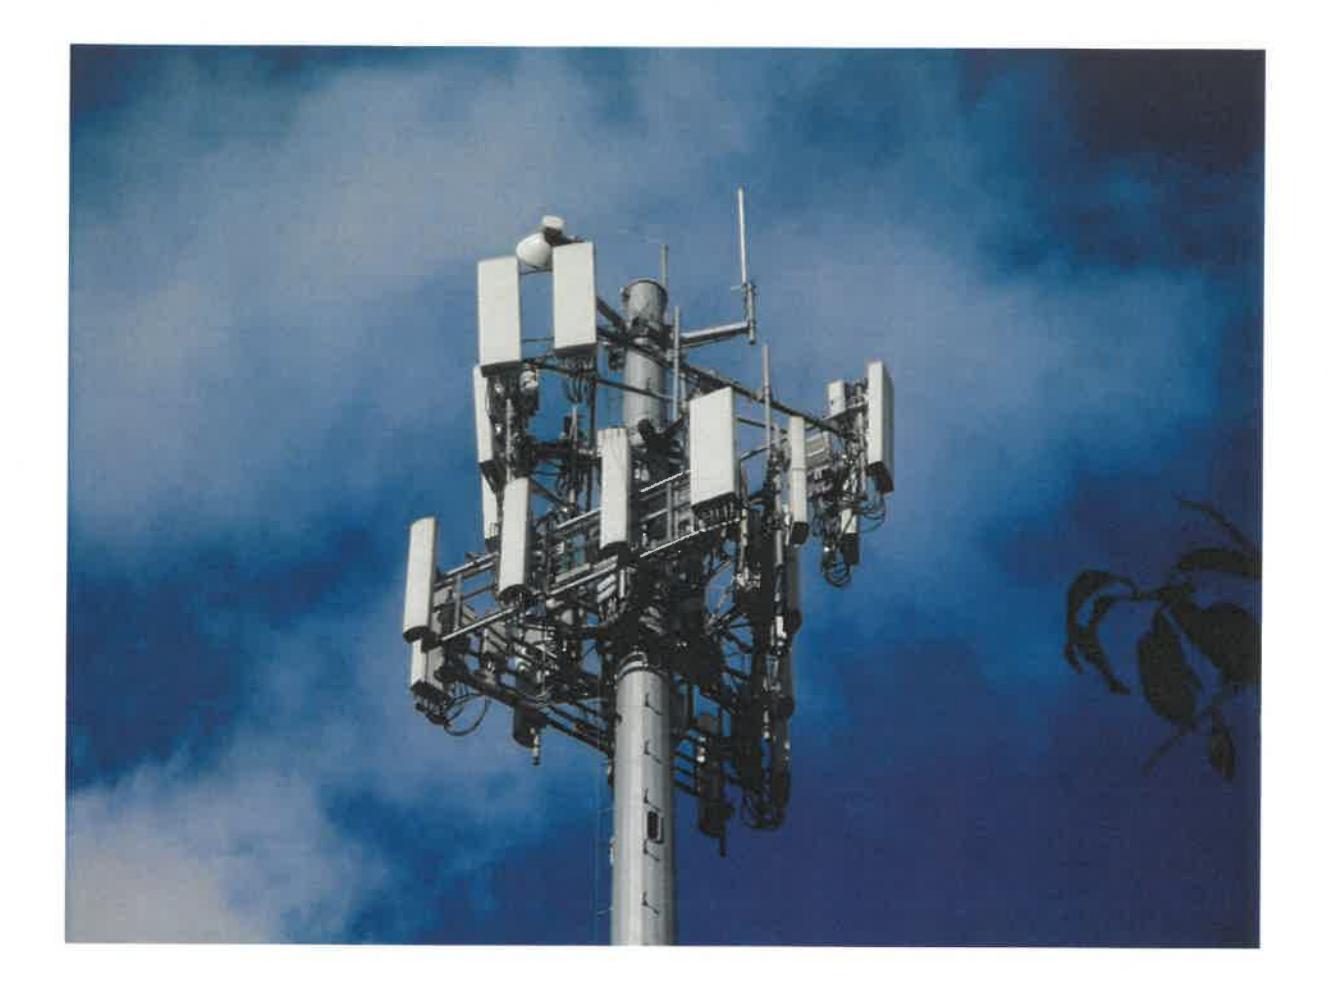
Photo 2: Existing Appurtenances

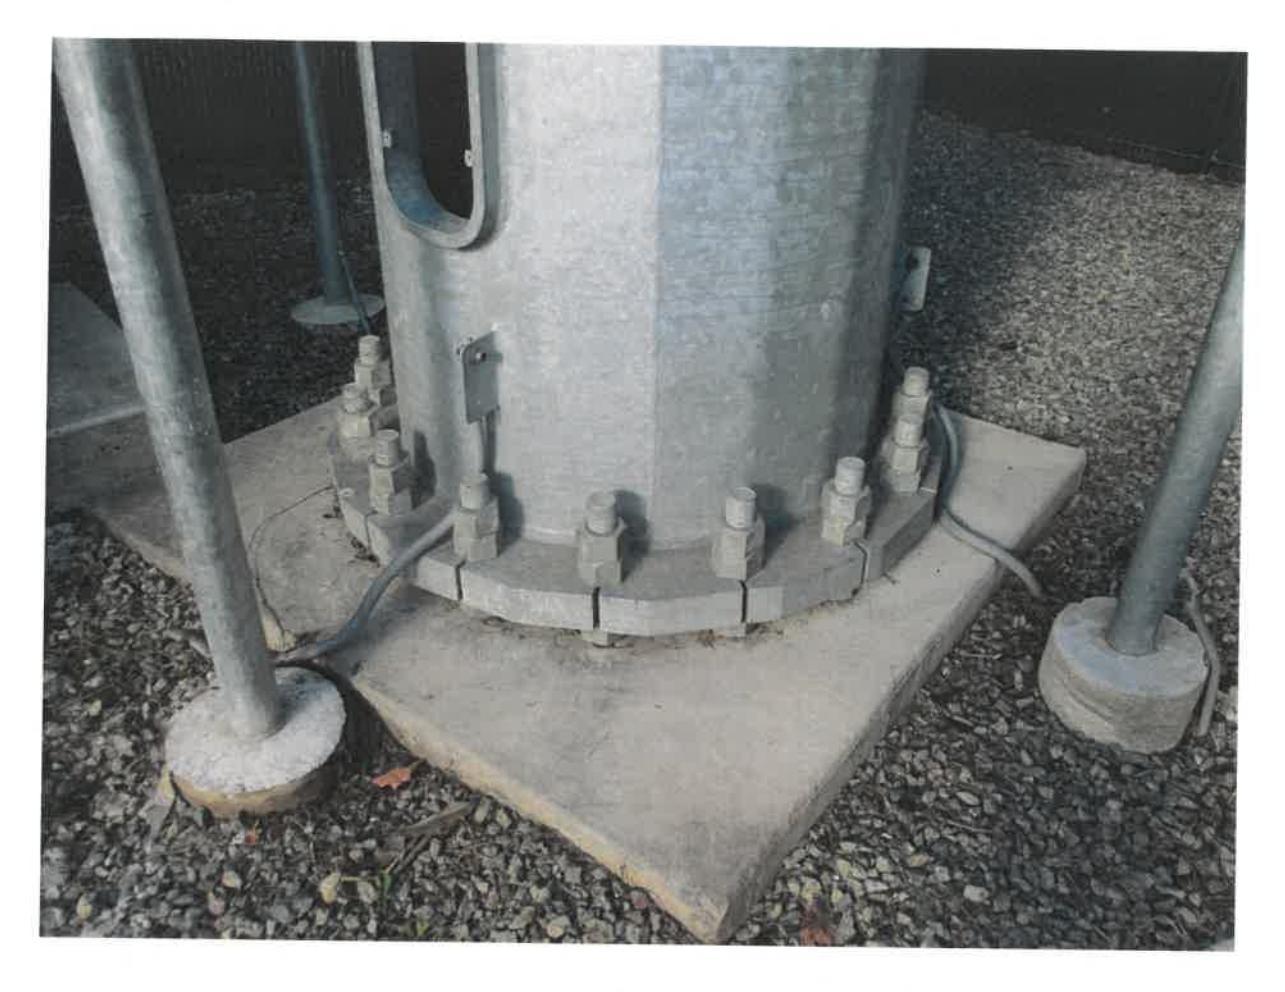
Photo 3: Pole Base and ground leads
