Signal Visibility Observations

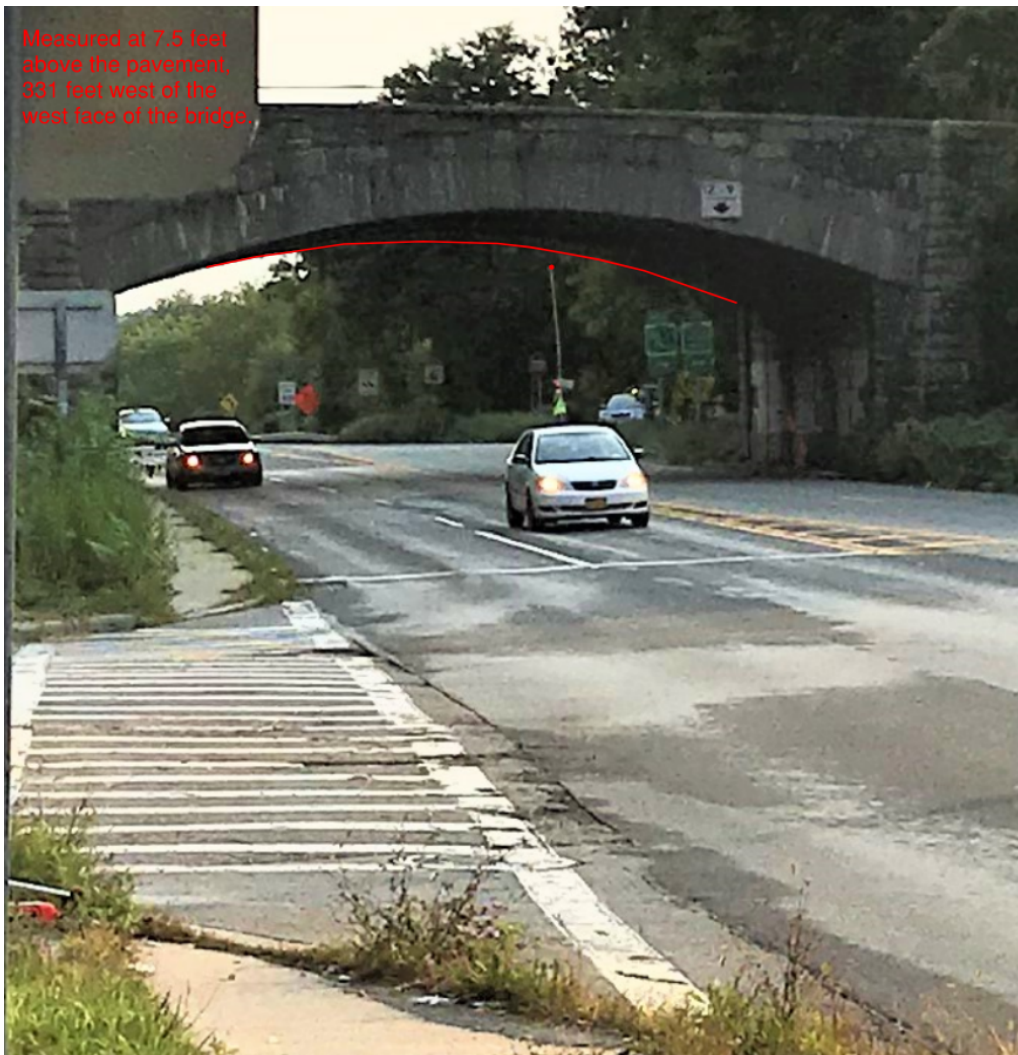
Measured at 7.5 feet above the pavement, 331 feet west of the west face of the bridge.

Red Signal Head Centered 19' over the roadway, when viewed from 7.5 feet over the Roadway
