**Wetland Survey
The Jerome Drive & Rt. 6 Site**

1 Jerome Drive
Tax ID 24.13 – 4- 1 & 52

Cortlandt, NY

June 15, 2023

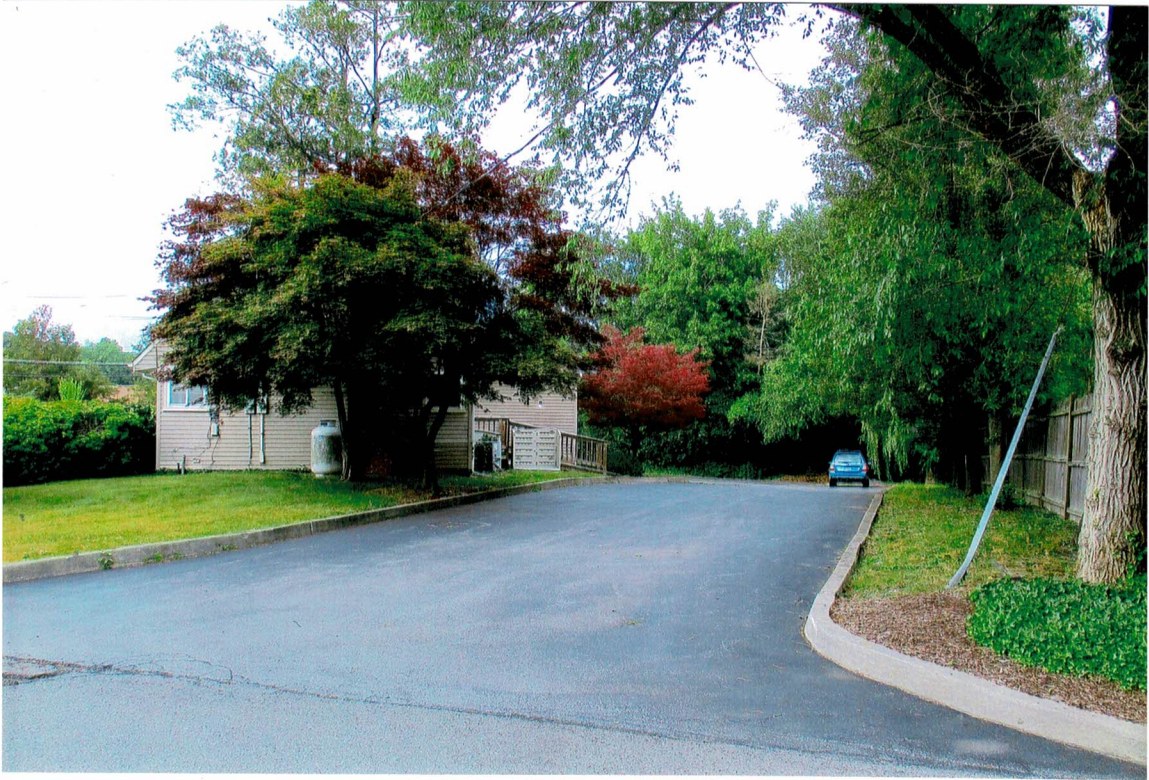
Photo 1 Looking northeast along paved driveway entrance into the site.

A paved driveway comes in off of the northeast side of Jerome Drive and into the southeast corner of the site (see *photo 1* in Appendix). The driveway continues northeast along the southeast property line for approx. 80 ft. to the paved parking area (see *photo 2* in Appendix I). The parking area covers most of northern portion of the site. A second driveway comes off of Rt. 6 and into the southwest corner of the site. This second driveway turns northeast for approx. 40 ft. and connects with the paved parking area.

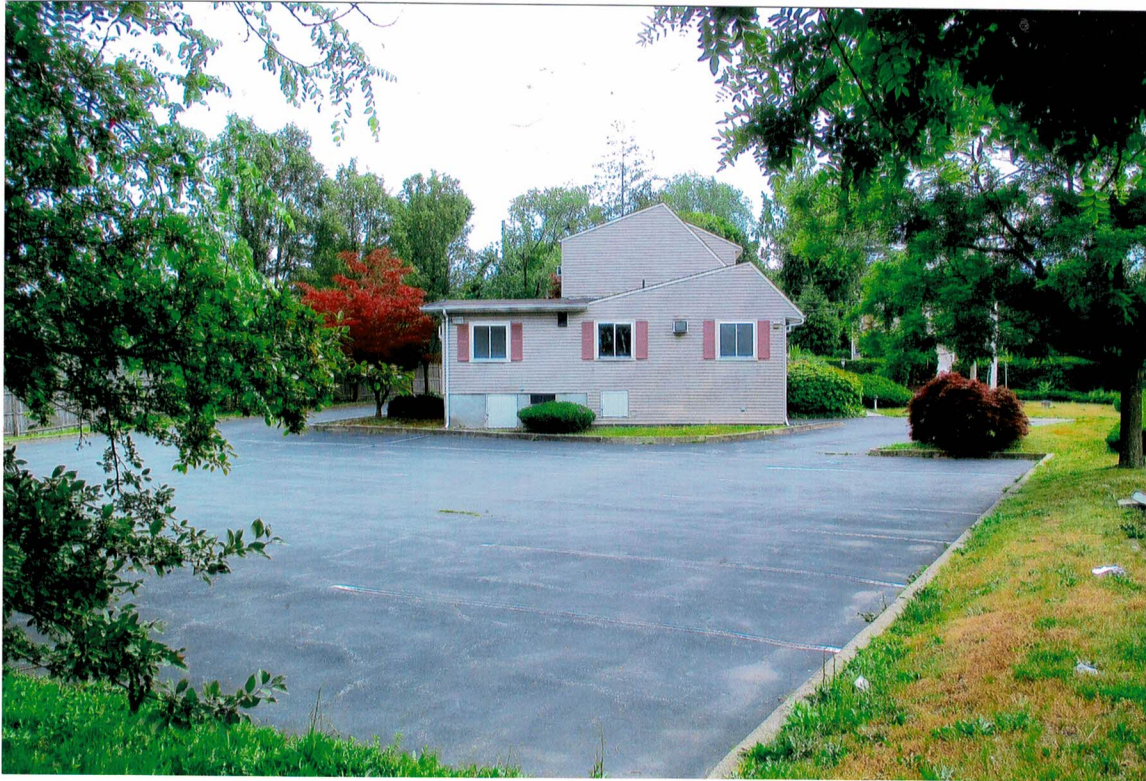
Photo 2 Looking south across paved parking area. Note building in center of photo.

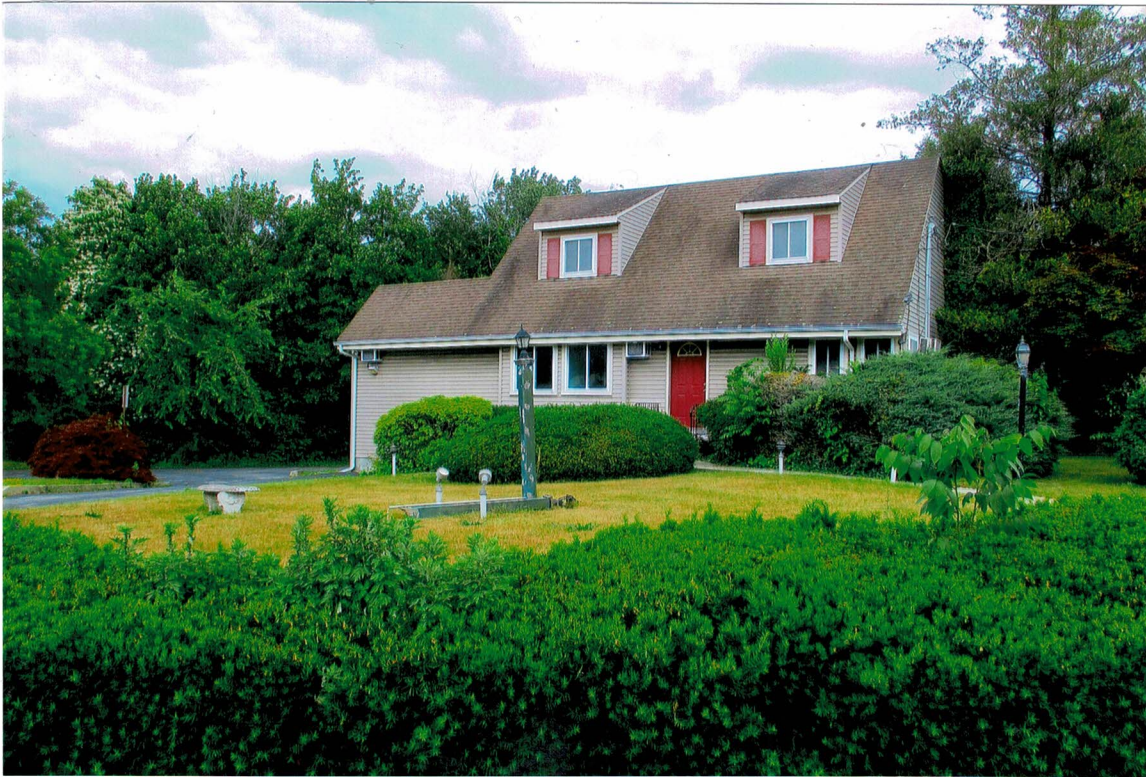
Photo 3 Looking north from Jerome Drive and toward building.

The building is located on the southwest-central portion of the site (see *photo 3* in Appendix I).

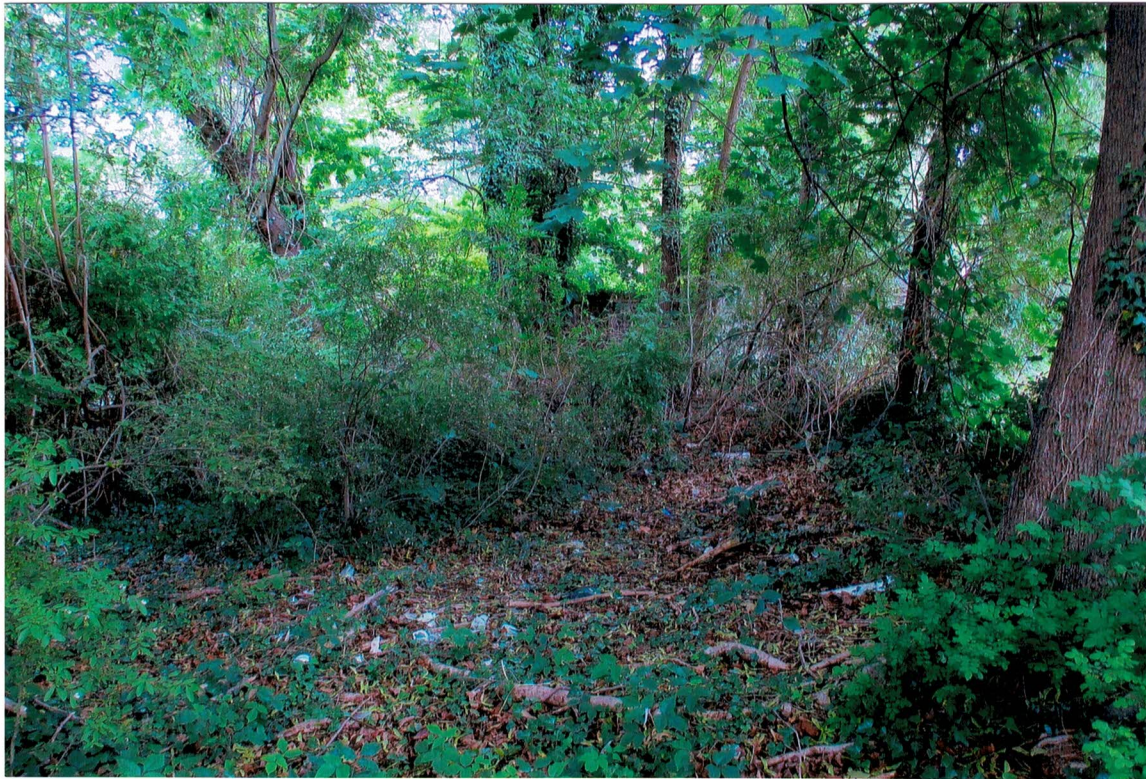
Photo 4 Looking southeast across woodlands on the northern end of the site. Note scattered man-made debris on woodland floor.

Woodlands borders are on the northeast end of the site (see *photo 4* in Appendix I). Woodlands have a canopy of Norway maple, a few Northern catalpa, locust, red maple, and elm. The woodland understory is relatively open except for a few privet and winged euonymus shrubs. The groundcover is covered with English ivy in many places. Twig and leaf litter covers the woodland floor. There is some scattered man-made debris littering the woodlands.

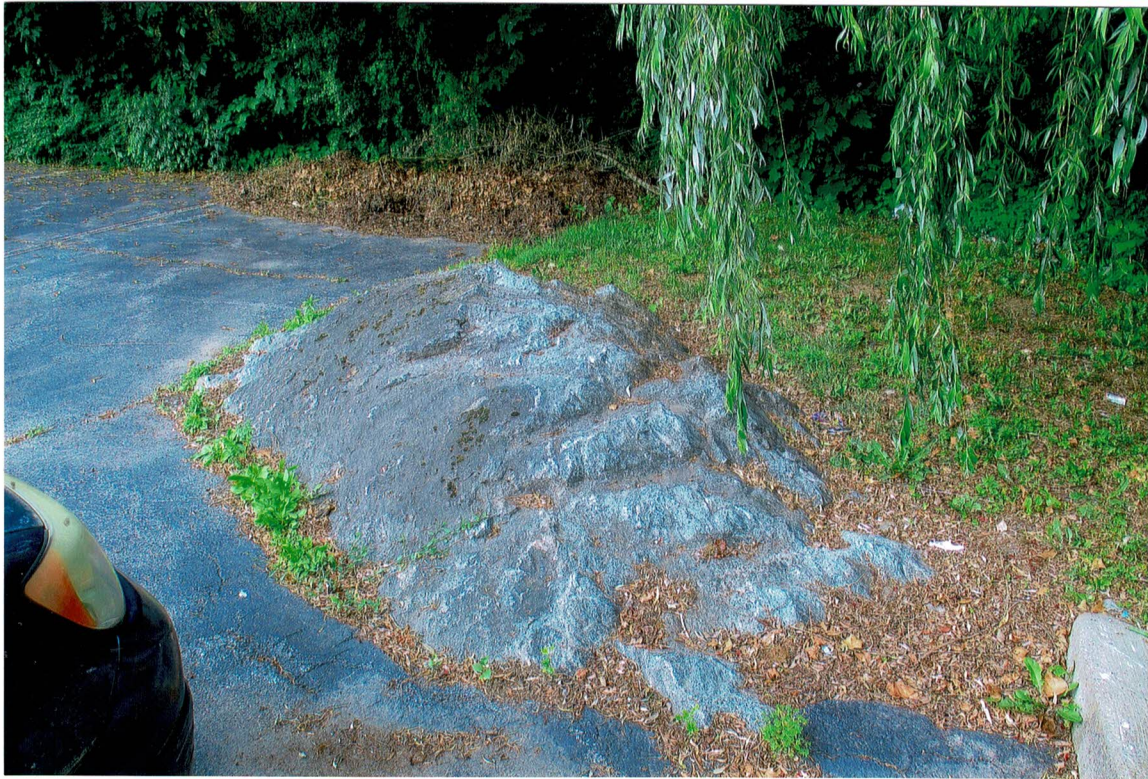
Photo 5 Looking close-up at partly buried rock at northeast corner of parking lot.

There is a large partly buried rock situated on the northeast corner of the parking area (see *photo 5* in Appendix I).

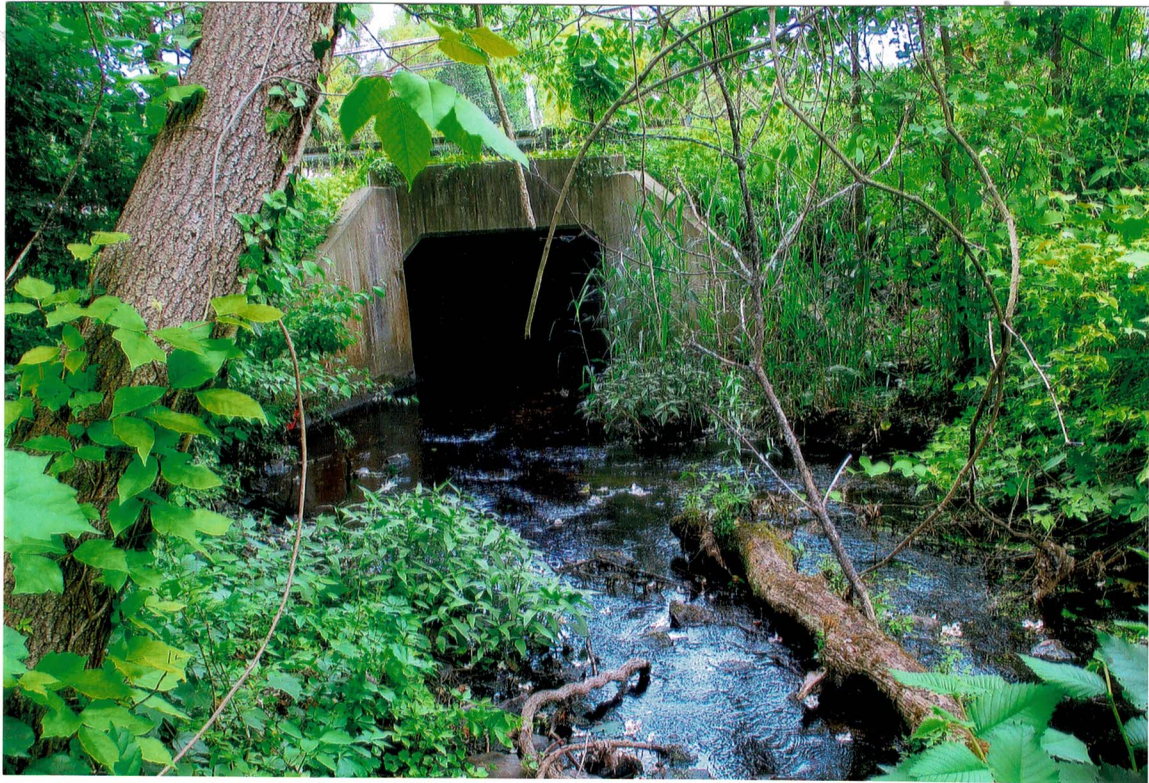
*Photo 6 Looking northwest and downstream along brook flowing into culvert under Rt. 6.
June 2023- 1 Jerome Drive, Cortlandt, NY*

A brook, with a well-defined channel, flows northwest along the northeast property line (see *photo 6* in Appendix I). The brook channel is approx. 10 to 15 ft. across and 2 to 3 ft. deep. The channel banks are steep. The gradient of the brook is nearly flat. Approx. 6 inches deep water flows on the channel at this time. The channel bed of the brook is lines with sandy and gravelly deposition and point bars. A few phragmites grow along some sides of the brook. Multiflora rose forms dense hedges along the top of bank of the brook. The brook flows out from a large swampland wetlands area containing Gregory Pond, located to the east and southeast of the site. The wetlands area covers many acres. The brook flows along the site property line to a box culvert located just north of the northernmost corner of the site. The brook flows through the culvert under Rt. 6 and away from the site. There does not appear to be any evidence of soils erosion or deposition from overtopping or flooding into the adjacent woodlands along this section of the brook.

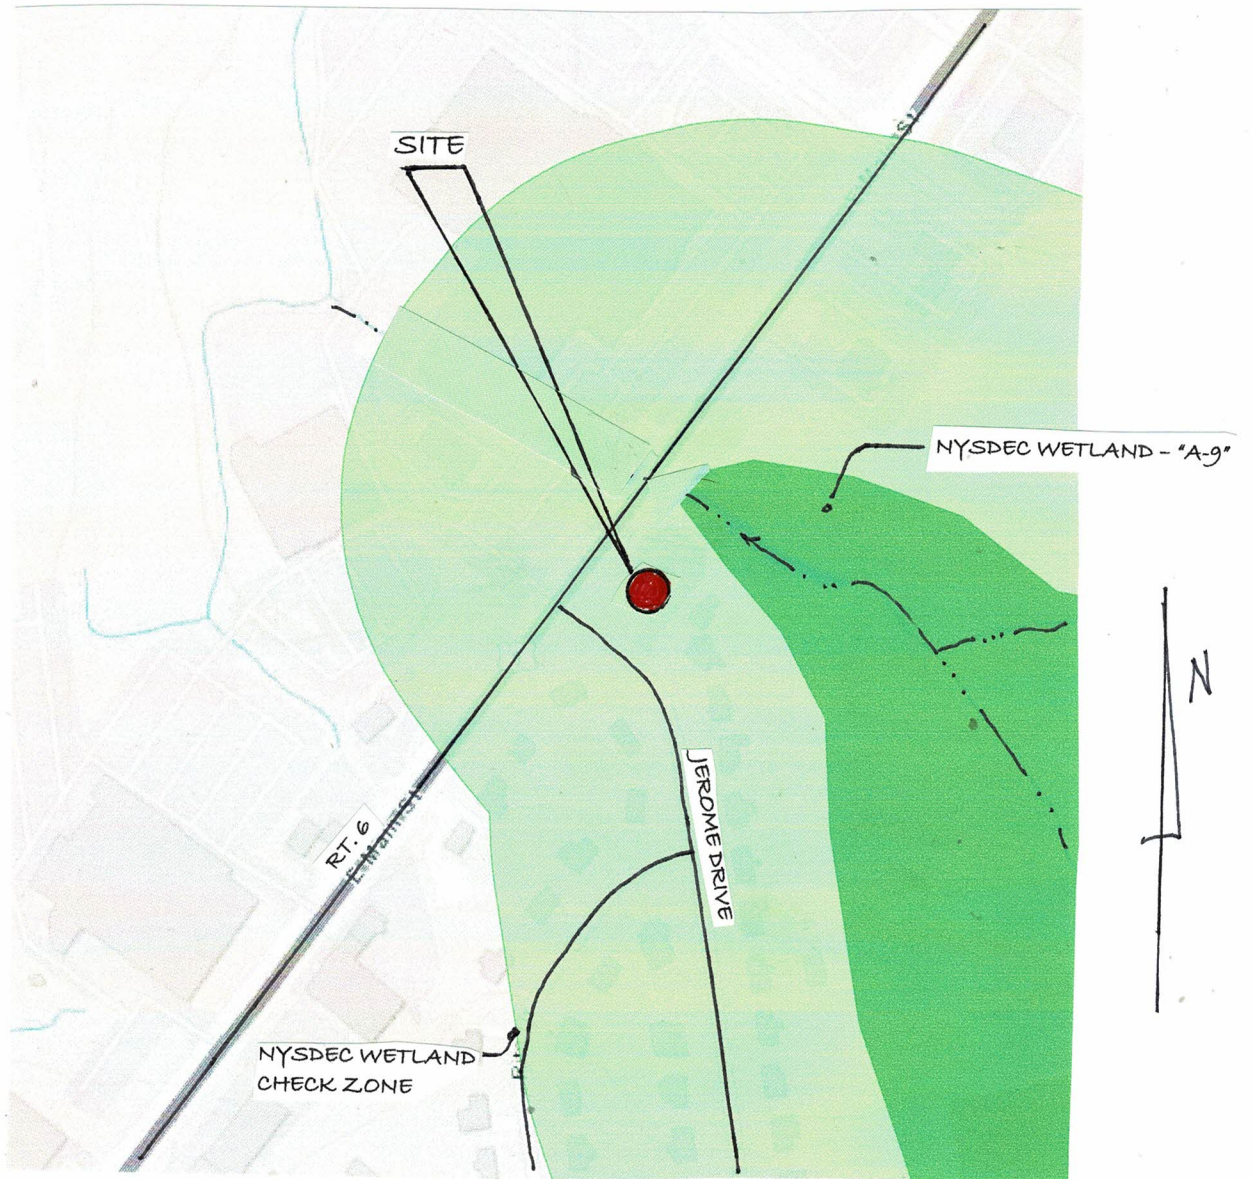
NYSDEC WETLAND MAP
N.T.S.

The wetlands area adjacent to the site is identified as New York State Department of Environmental Conservation (NYSDEC) jurisdictional wetlands “A-9”, according to a review of the agency’s published maps (see *NYSDEC Wetland Map* in Appendix II). The brook is a *Class C* watercourse according to the agency’s published maps.

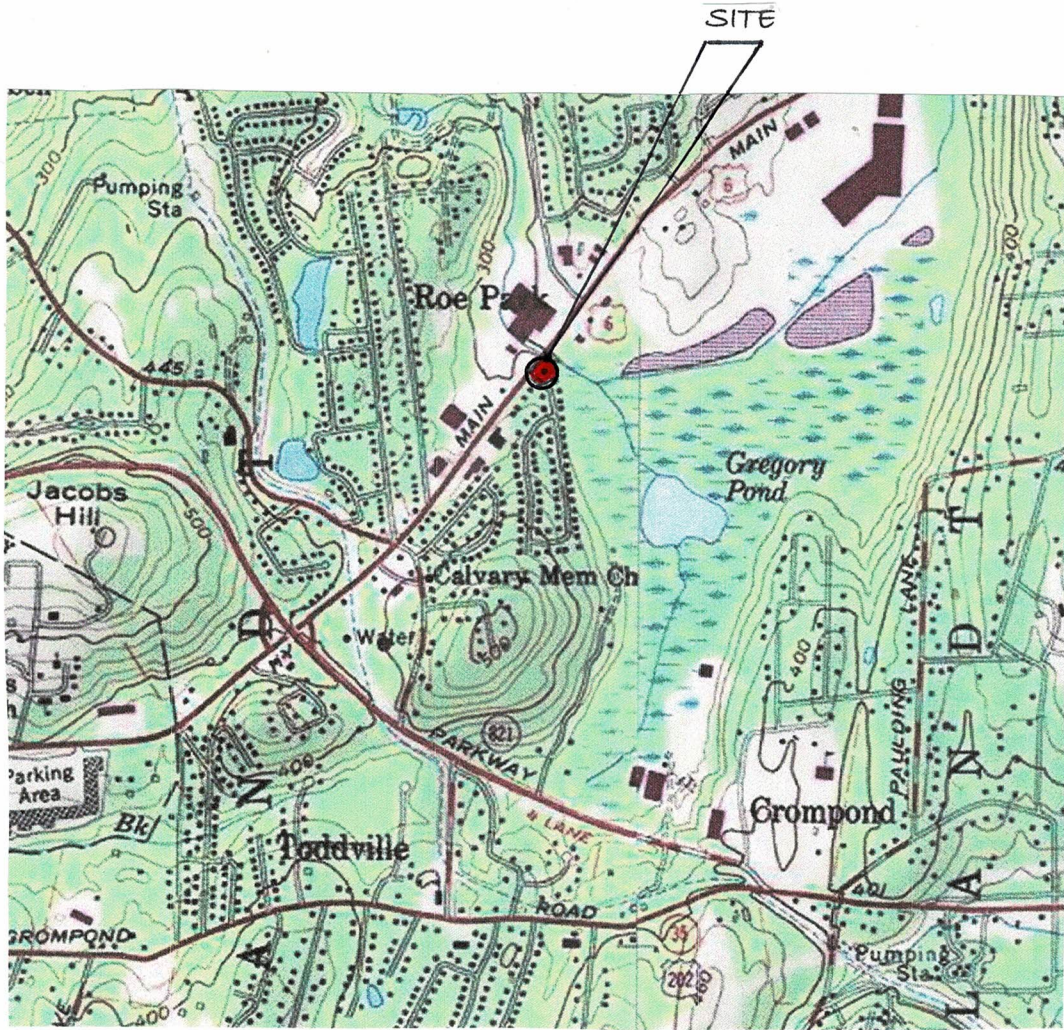
REGIONAL DRAINAGE MAP
N.T.S.

Drainage from the site is directed northeast toward the brook located along the northeast edge of the site. The brook flows northwesterly for approx. 1.5 miles to the Peekskill Hollow Brook (see *Regional Drainage Map* in Appendix III).

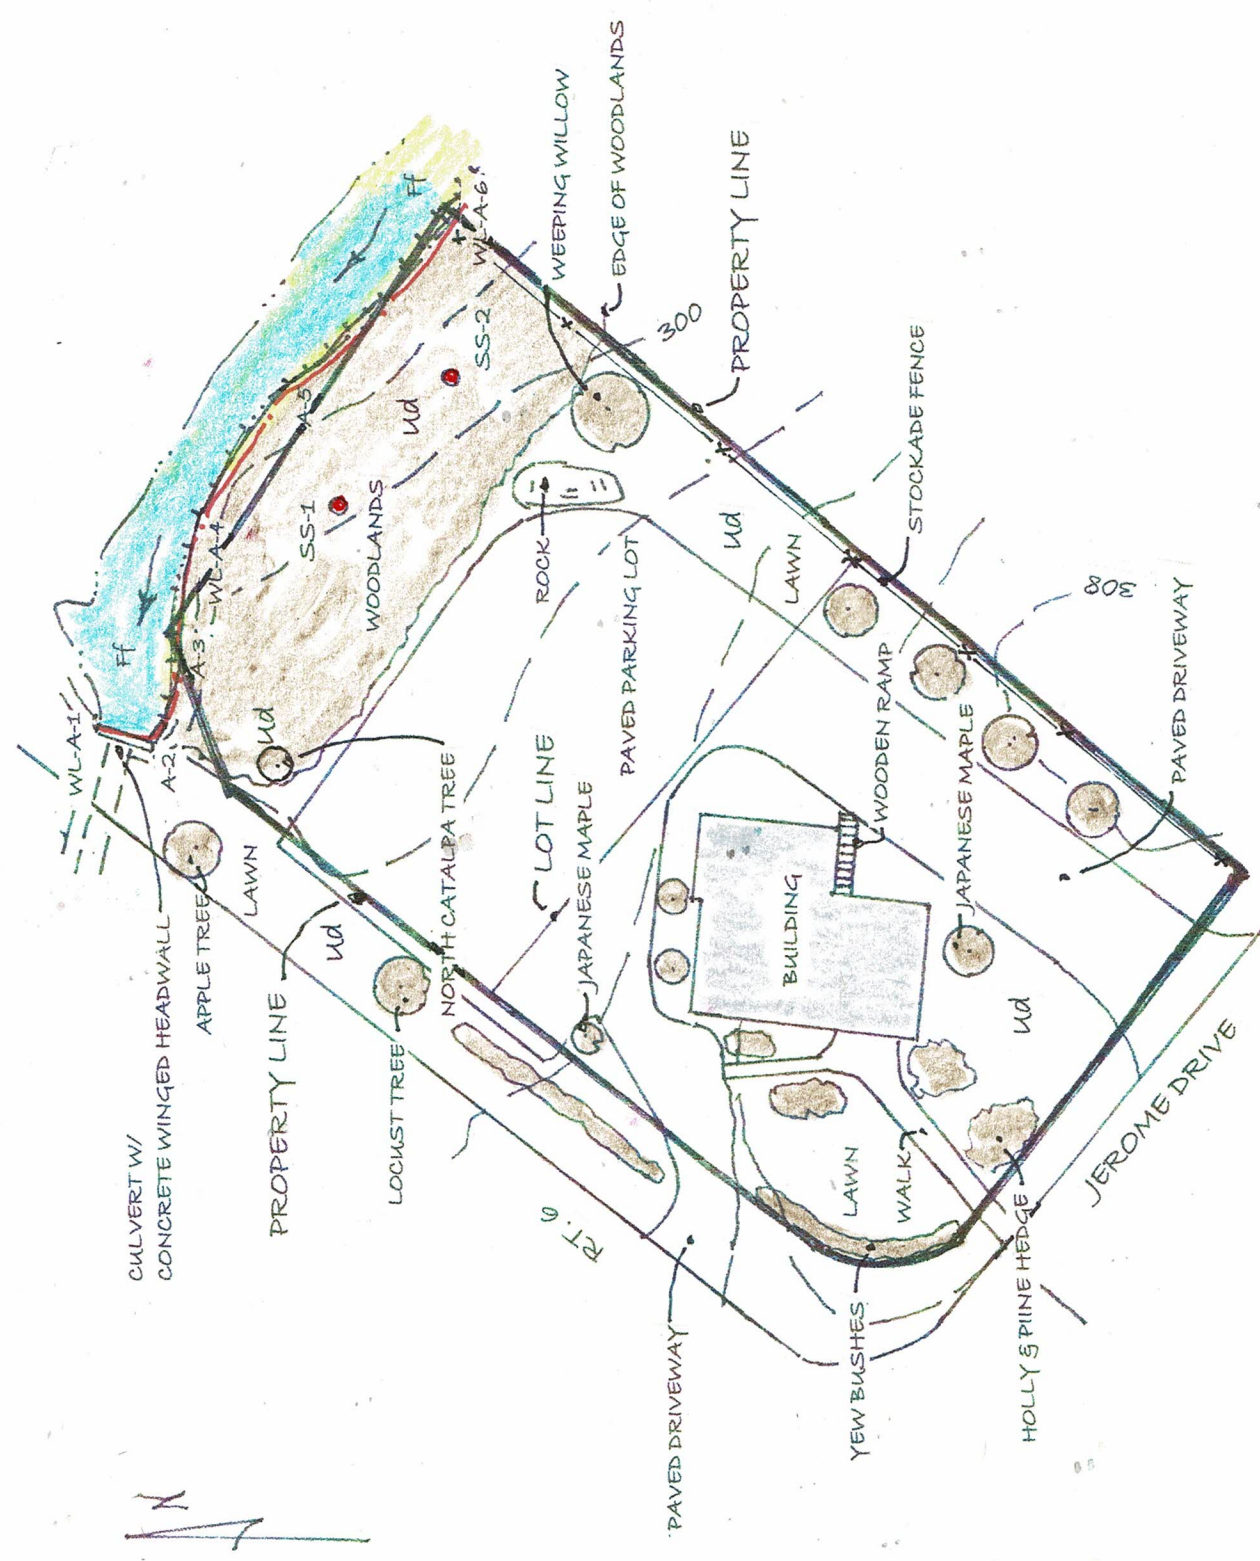
Wetlands & Soils Map
 The Jerome Drive Site
 1 Jerome Drive & Rt 6
 TAX ID 24.13 - 4 - 1 & 52
 Cortlandt, NY

The Wetland boundary and watercourses were delineated on the site with consecutively numbered flagging (WL-A-1, WL-A-2, WL-A-3, etc.) and plotted on the enclosed *Wetland and Soils Map*. Wetlands on the site consist of: a brook with associated wetlands located along the northeast property line.

Shallow soil borings were taken using a spade and Dutch auger at selected locations throughout the site in order to identify wetland soils. Soil boring locations (SS-1, SS-2, etc.) were plotted approx. on the enclosed *Wetland and Soils Map*. Soil borings were logged noting soil profile color, texture, redoximorphic (wetland soil) indicators, and water table. Detailed descriptions of soil borings are provided in Appendix IV.

Soils encountered on the site include: non-wetland, well drained Udorthents (Ud), slopes varied, to describe areas of soil cut, fill, and grading done around the building, lawn area, woodlands, and around the driveway and parking lot as part of the original development of the site; wetland, very poorly drained Fluvaquents (Ff), slopes 0 to 3 %, to describe young wetland soil profiles formed along the active watercourse channel. The distribution of these soil-types is depicted on the enclosed *Wetlands and Soils Map*.
