**Re: Croton Avenue Solar Project (fka Hanover Estates)
200 Croton Avenue
Site Development Plan**

CROTON AVENUE SOLAR PROJECT SUPPLEMENTAL REPORT

Croton Avenue Solar Project: Compliance Analysis of Town of Cortlandt Town Code Chapter 255, Section 255-8: Permitting Requirements for Tier 3 Solar Energy Systems

Croton Avenue Solar Project Decommissioning Plan

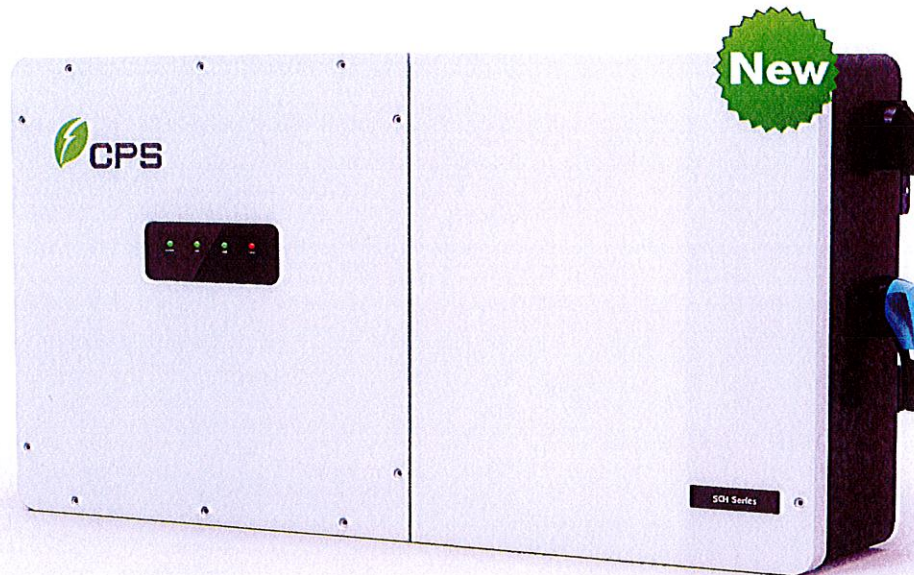
CPS SCH100/125KTL-DO/US-600

The 100 & 125kW medium power CPS three phase string inverters are designed for ground mount applications. The units are high performance, advanced and reliable inverters designed specifically for the North American environment and grid. High efficiency at 98.8% peak and 98.5% CEC, wide operating voltages, broad temperature ranges and a NEMA Type 4X enclosure enable this inverter platform to operate at high performance across many applications. The CPS 100/125kW products ship with the standard wire-box, each fully integrated and separable with touch safe fusing, monitoring, and AC and DC disconnect switches. The CPS Flex Gateway enables communication, controls and remote product upgrades.

- NEC 2014/17 compliant & UL listed Arc-Fault circuit protection
- Touch safe DC Fuse holders adds convenience and safety
- CPS Flex Gateway enables remote FW upgrades
- Integrated AC & DC disconnect switches
- 1 MPPT with 16 and 20 inputs for maximum flexibility
- Copper and Aluminum compatible AC connections
- NEMA Type 4X outdoor rated, tough tested enclosure
- Advanced Smart-Grid features (CA Rule 21 compatible)
- kVA Headroom to deliver full Active Power @ 0.95PF
- Generous 1.5 DC/AC Inverter Load Ratio
- Separable wire-box design for fast service
- Standard 10 year warranty with extensions to 20 years
